# Viera East Community Development District

Inspected: September 12, 2024 • Revised on: June 06, 2025  
Rockledge, FL

RESERVE STUDY

Viera East Community Development District  
Rockledge, Florida

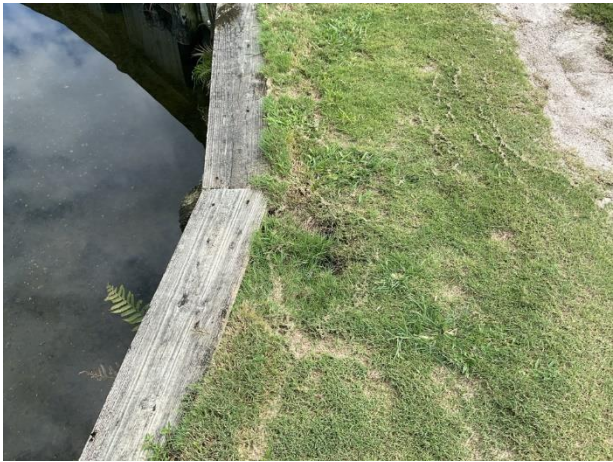
**Condition:** Good to fair overall with minor erosion evident at the ends and backsides

**Erosion at backside of Hole 7 bulkhead**

**Useful Life:** Inspections and capital repairs every 15- to 20-years and complete replacement up to every 30 years

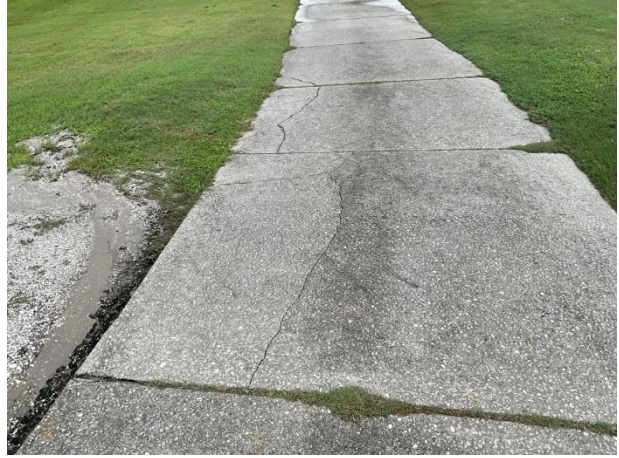
**Concrete cracks**

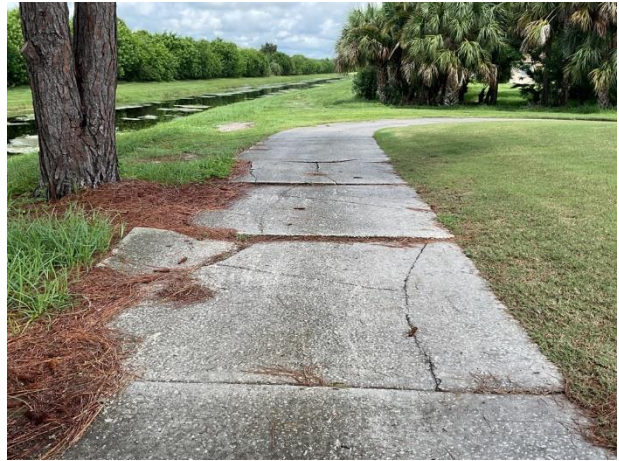
**Significant tree root intrusion near hole 11 tee area**

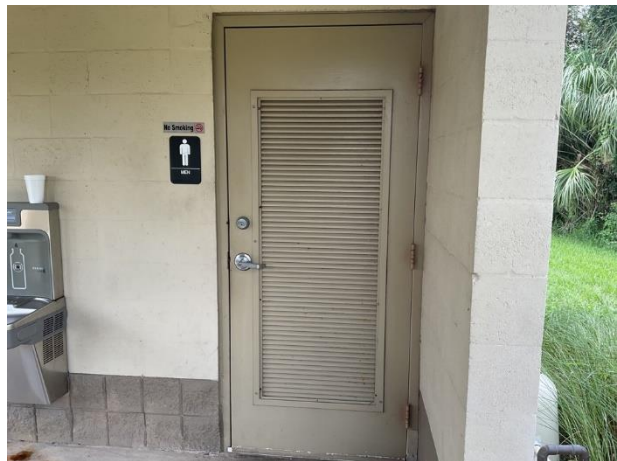
**Condition:** Fair overall. We note rust at the rest room doors

**Rest room door with rust evident**

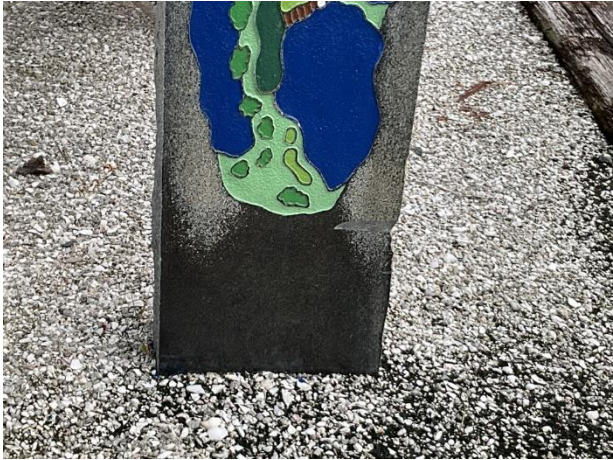
**Condition:** Good to fair overall with leaning markers and damage evident

**Damage to Hole 7 yardage marker**

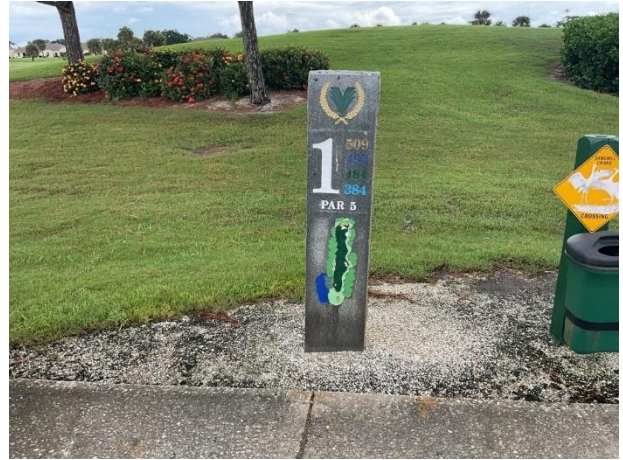
**Leaning marker at Hole 1**

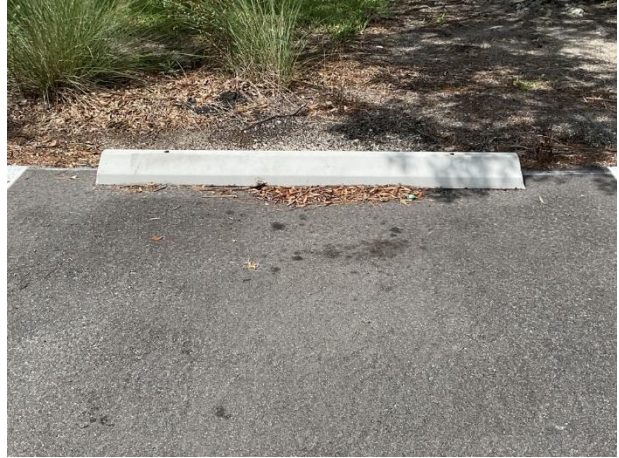
**Vehicle fluid stains**

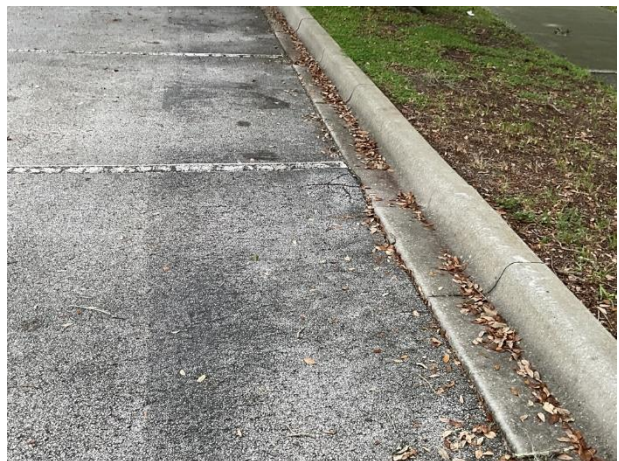
**Evidence of tree root intrusion**

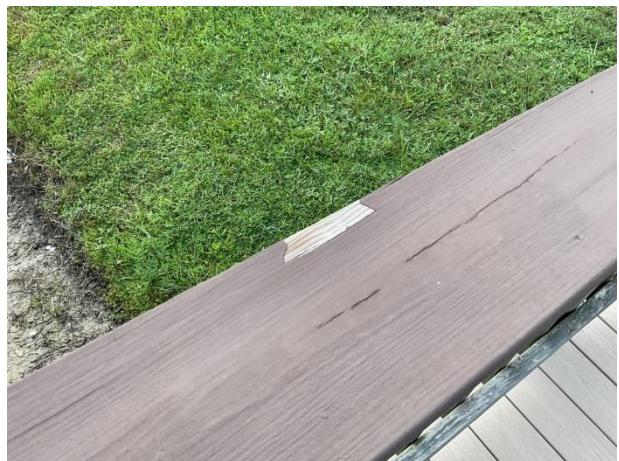
**Handrail coating deterioration**

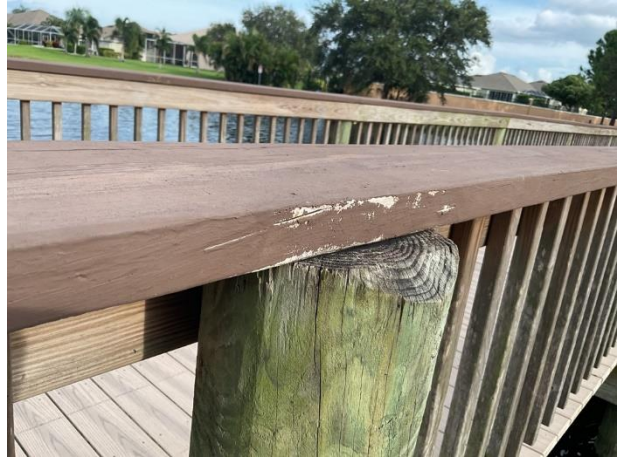
**Railing finish deterioration**

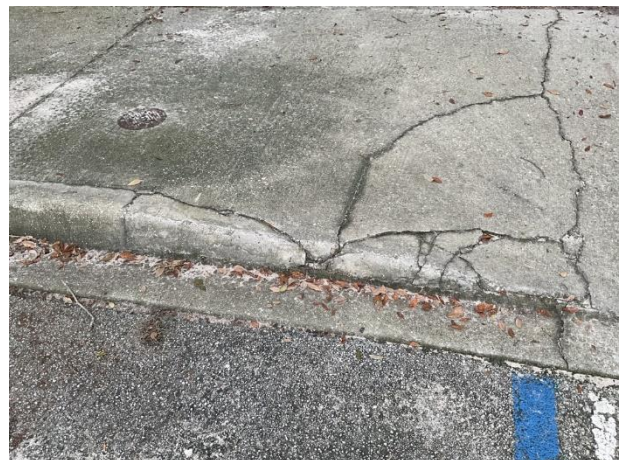
**Concrete deterioration at Woodside Park**

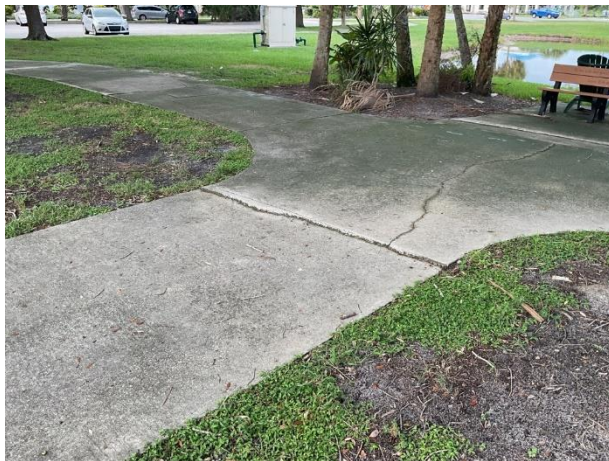
**Condition:** Fair overall with cracks, trip hazards and settlement throughout.

Concrete cracks and trip hazards near  
playground

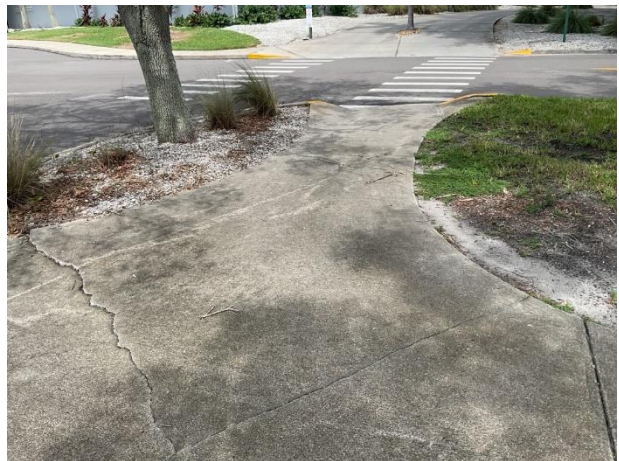
Concrete sidewalk with cracks and trip hazards  
at Clubhouse

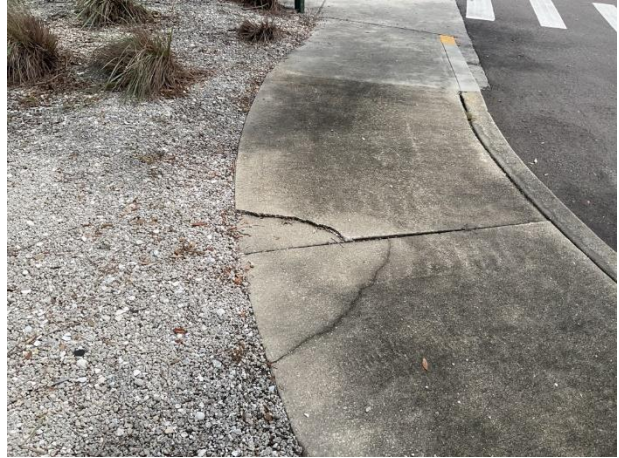
**Sidewalk trip hazard**

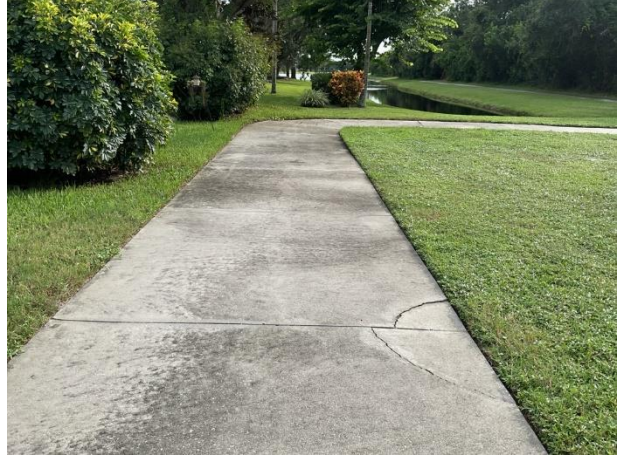
**Concrete sidewalk with cracks and settlement near Fawn Ridge**

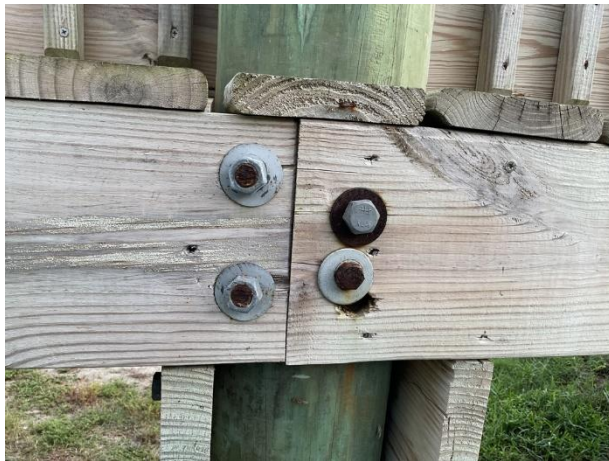
**Condition:** Good to fair overall with rust evident at fasteners

Rust at fasteners

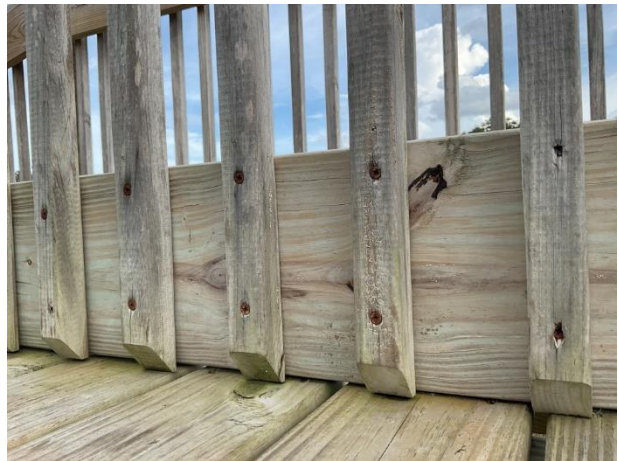
Rust at visible screwheads at railings

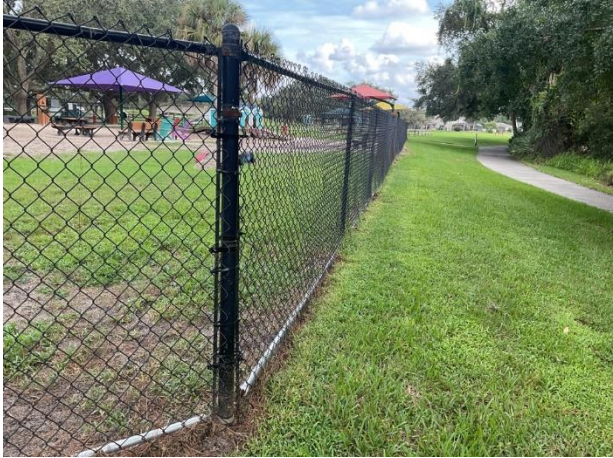
**Condition:** Good to fair overall with rust evident at fasteners. We note warped webbing

**Chain link fence at dog park with warped webbing**

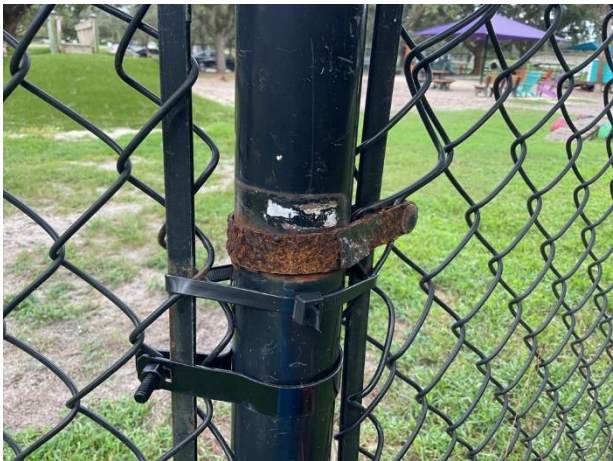
**Rust at fence hardware**

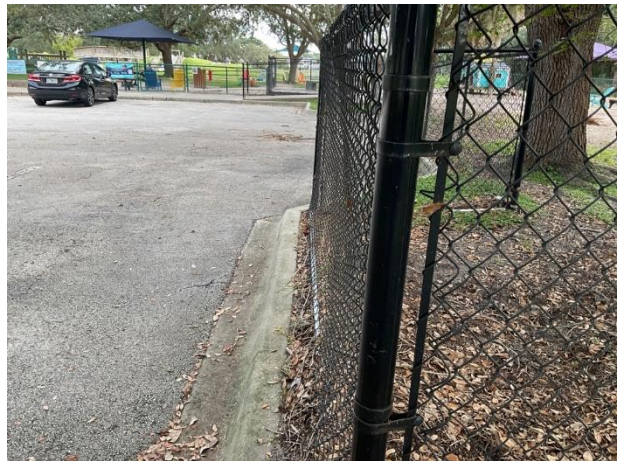
**Warped webbing**

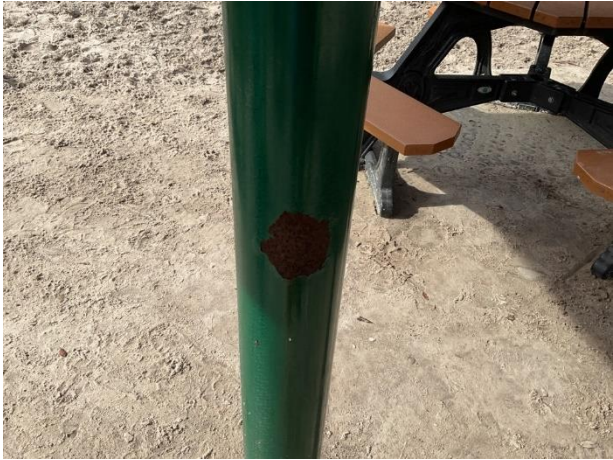
**Condition:** Good to fair overall with rust and stained canvas evident

**Rust at frame**

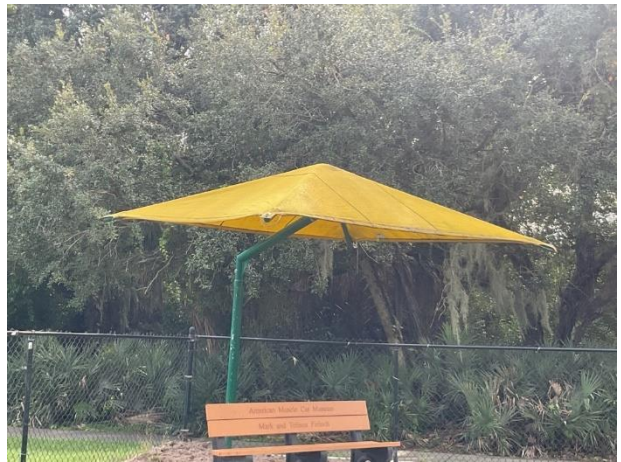
**Shade structure with stained canvas**

**Useful Life:** Up to 25 years with interim replacement of the canvas every six- to eight-years

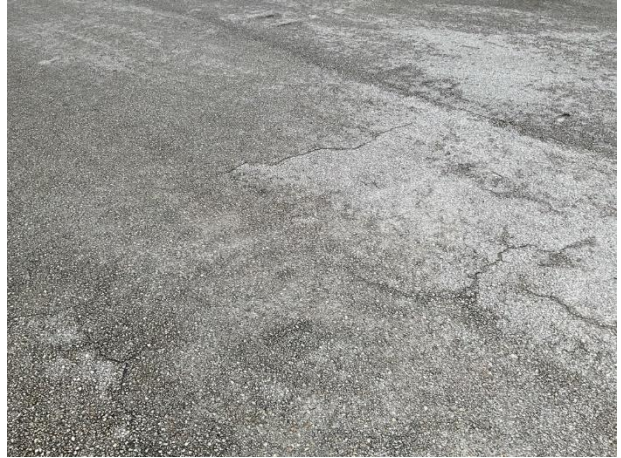
**Condition:** Fair overall with cracks and settlement evident

**Pavement cracks**

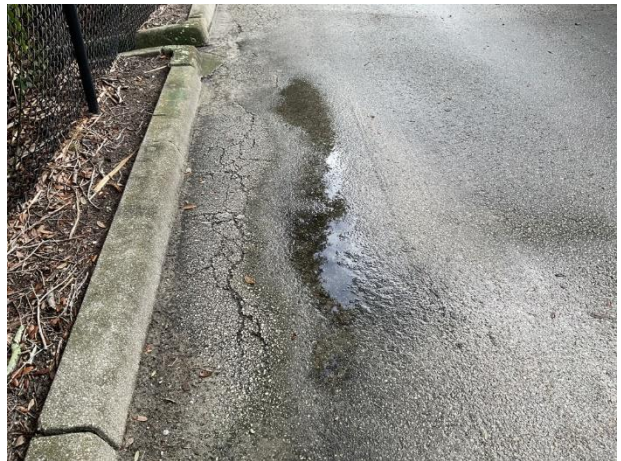
**Standing water**

**Useful Life:** 15- to 20-years with the benefit of patch repairs and seal coat applications every three- to five-years

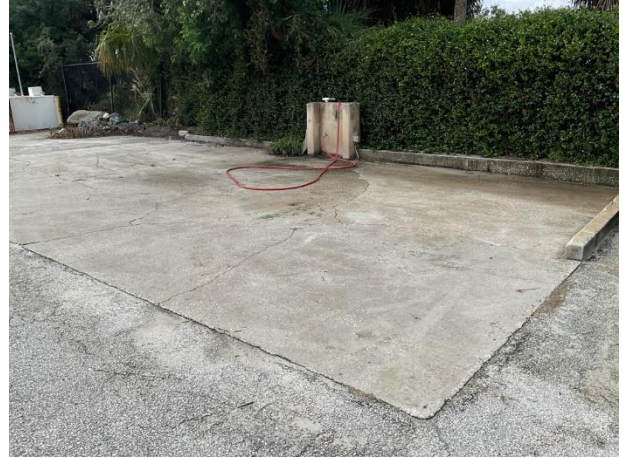
**Concrete cracks at wash station**

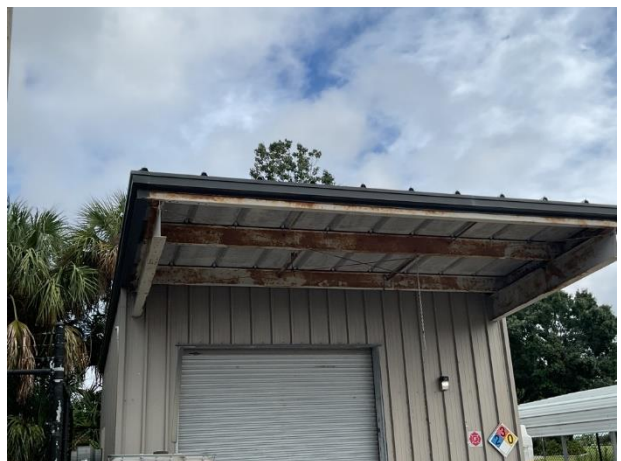
**Conditions:** The utility and overhead doors appear in good to fair overall condition with paint finish deterioration evident. The exhaust fan was in operation at the time of our inspection and Management did not report any deficiencies. The metal framing, siding and roofing is in fair overall condition with rust evident.

**Rust**

**Useful Lives:** The overhead door has a useful life of up to 25 years with proper maintenance, and the utility door has a useful life of up to 30 years. The exhaust fan has a useful life of up to 20 years although interim component replacement may be required. The metal roof and siding has a useful life of up to 45 years with the benefit of paint finish applications performed every 8- to 10-years

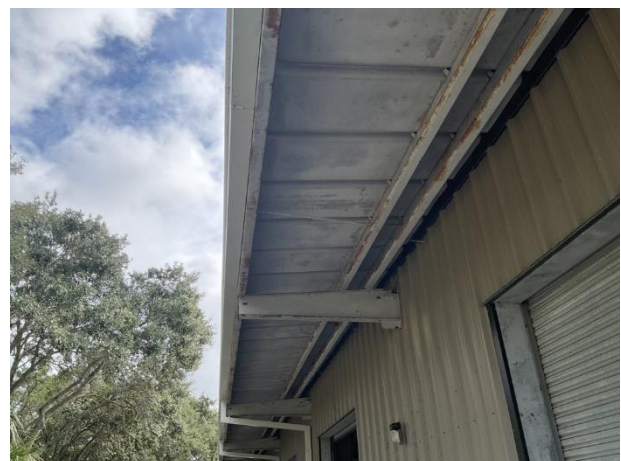
**Structural steel frame with rust evident**

**Useful Life:** Replacement of the roof and siding up to every 45 years with the benefit of interim paint finishes and repairs every 8- to 10 years. The useful life of the structural steel frame is indeterminate with proper maintenance.
