# Viera East Community Development District

Inspected: September 12, 2024 • Revised on: June 06, 2025  
Rockledge, FL

RESERVE STUDY

Viera East Community Development District  
Rockledge, Florida

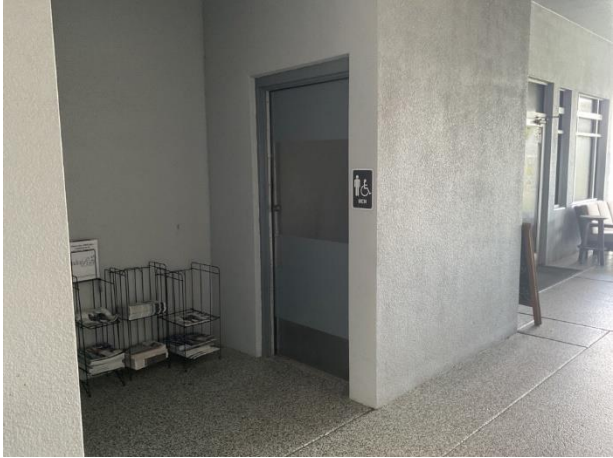
**Condition:** Good to fair overall with no significant visible deterioration

**Metal door at rest room**

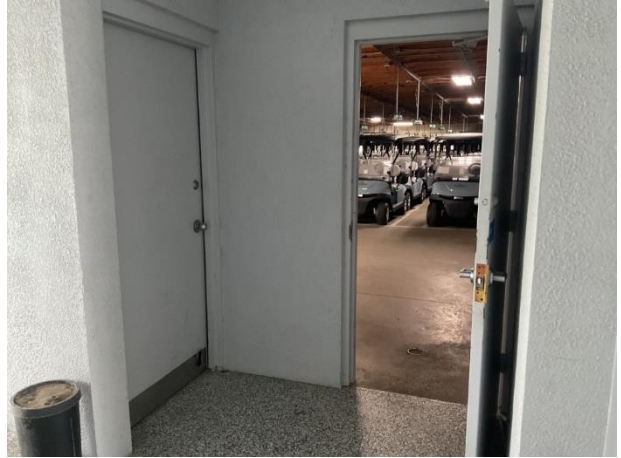
**Metal doors at cart barn**

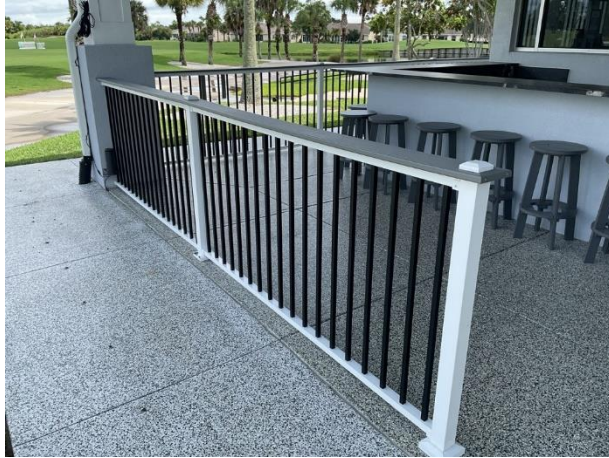
**Condition:** Good overall with no significant visible deterioration evident

**Aluminum railings at outdoor seating area**

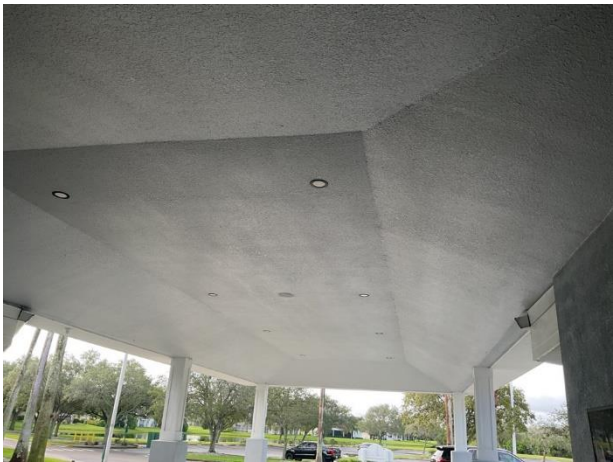
**Condition:** Good to fair overall with no visible deterioration evident.

**Stucco finishes at portico**

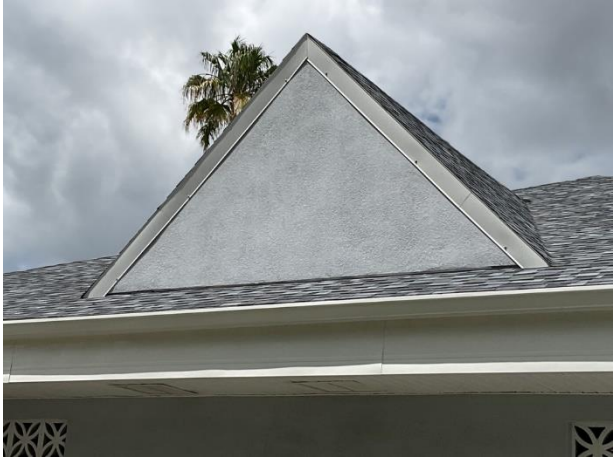
**Stucco terminates above lower roof section**

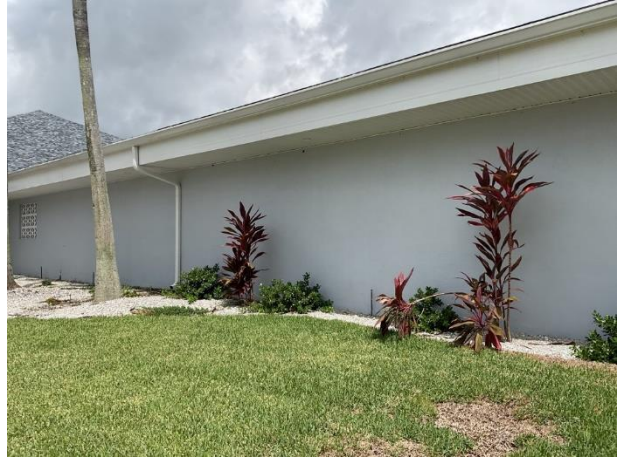
**Stucco wall finishes at cart barn**

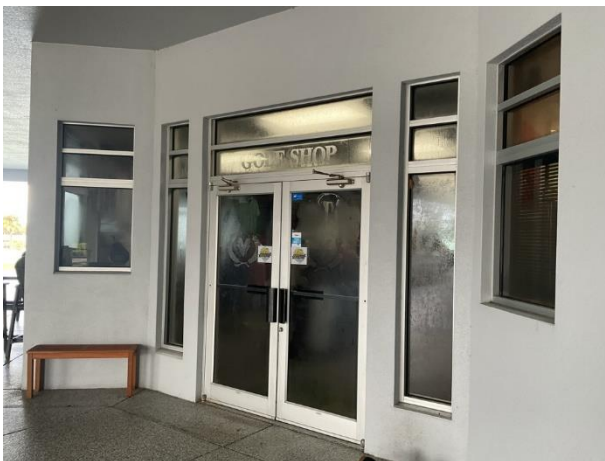
**Condition:** Good to fair overall with no significant visible deterioration

Windows and doors at Pro Shop

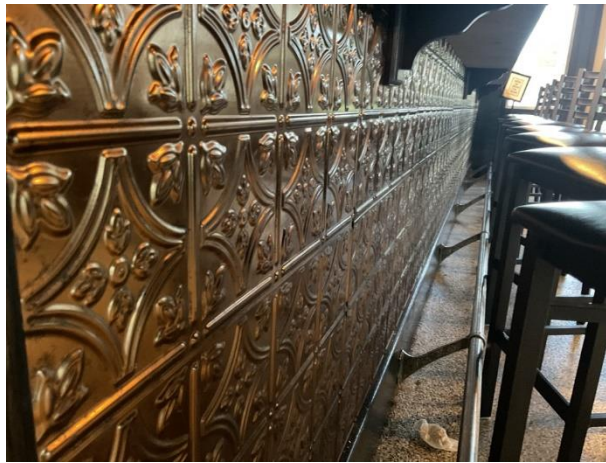
Plastic covering at bar

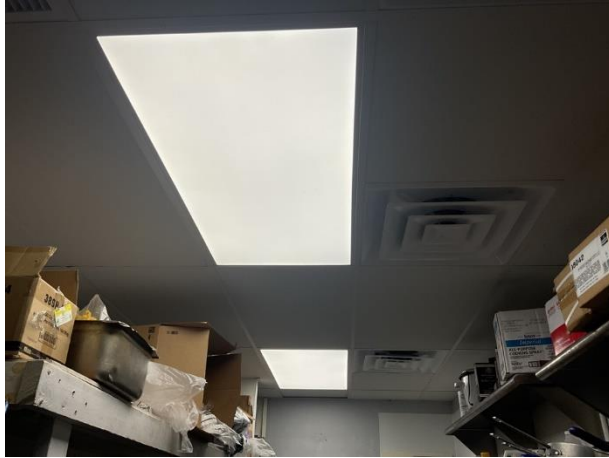
**Condition:** Good to fair overall with no significant deterioration evident. We did not identify significant stains, damaged tiles or rust at the vents.

**Acoustical ceiling at kitchen**

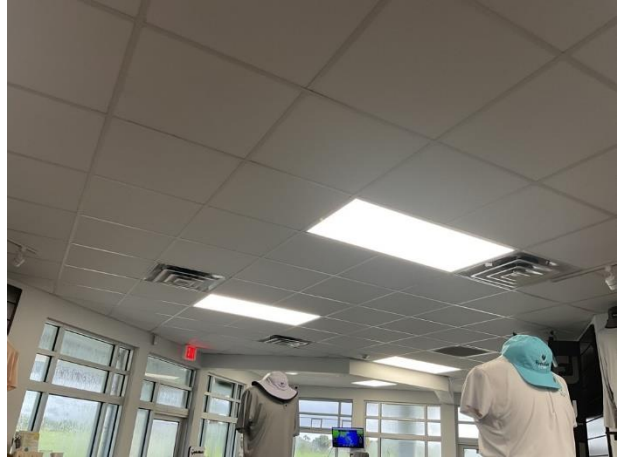
**Acoustical ceiling at pro shop**

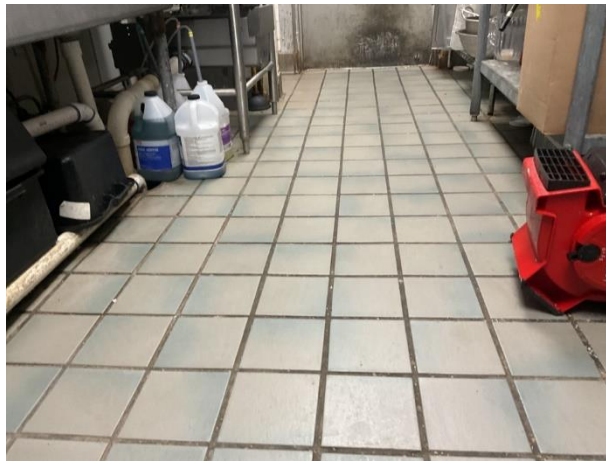
**Condition:** Fair overall with cracks and damaged tiles evident

**Tile floor coverings at dishwashing area**

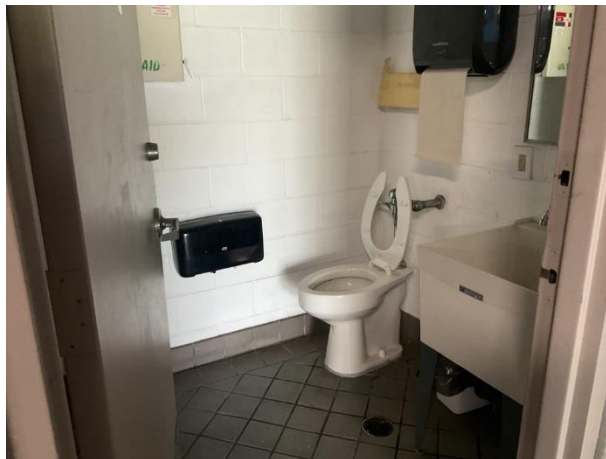
**Condition:** Good to fair overall

Rest room at cart barn

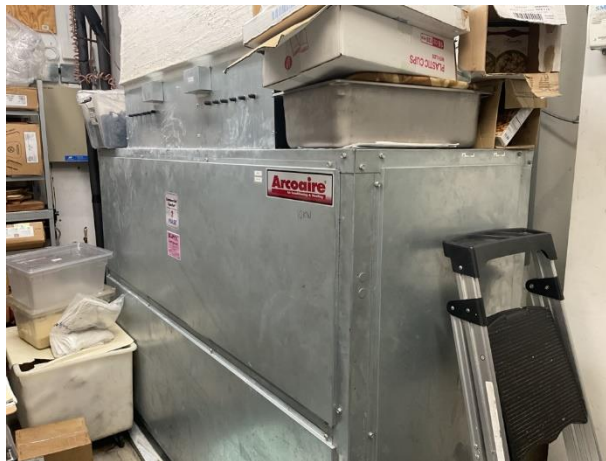
**Conditions:** Reported satisfactory without operational deficiencies

Air handling unit at restaurant

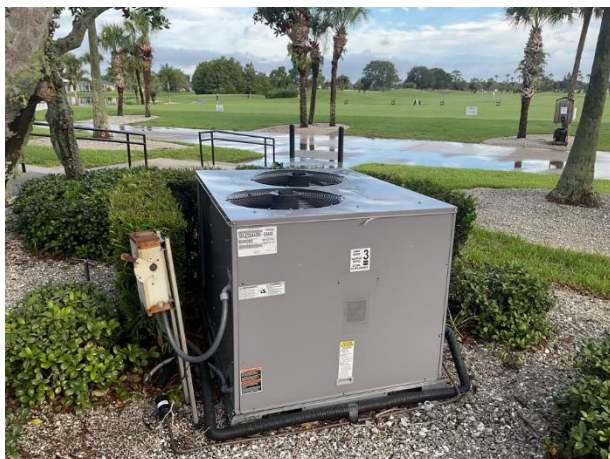
**Condition:** Reported satisfactory without operational deficiencies

**Condensing unit at pro shop and offices**

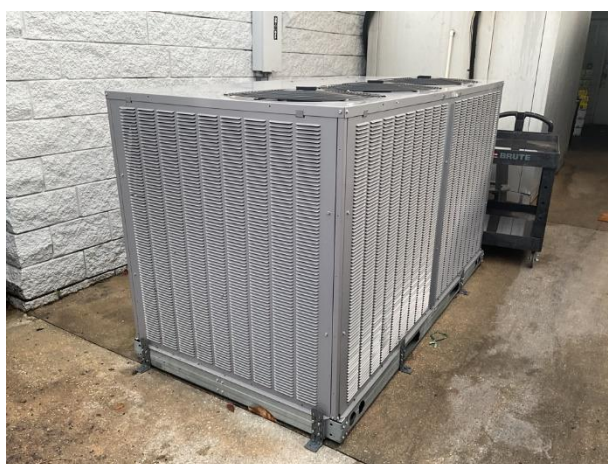
**Condensing unit at restaurant**

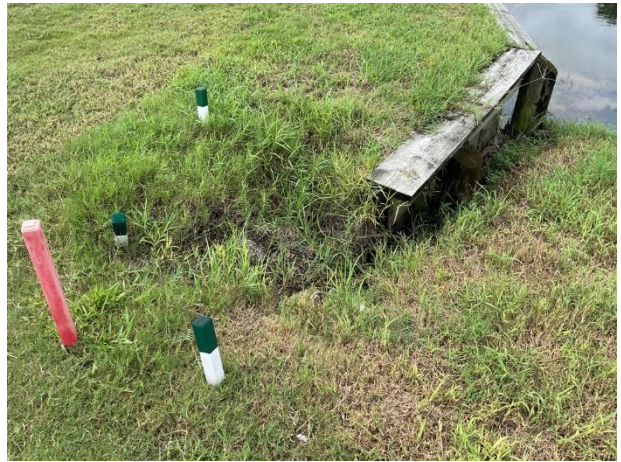
**Condition:** Good to fair overall with minor erosion evident at the ends and backsides

**Erosion at end of Hole 7 bulkhead**

**Expenditure Detail Notes:** Expenditure timing and costs are depicted in the **Reserve Expenditures** table in Section 3. Our cost for capital repairs includes allowances for a complete inspection and partial replacement of up to ten percent (10%), or approximately 105 linear feet, of the timber bulkheads.

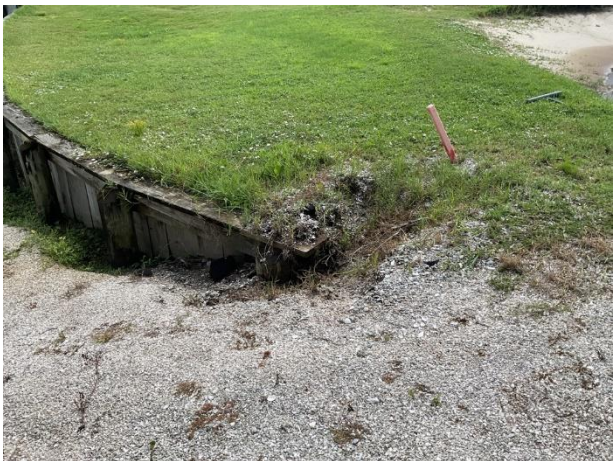
**Erosion at end of Hole 7 bulkhead**

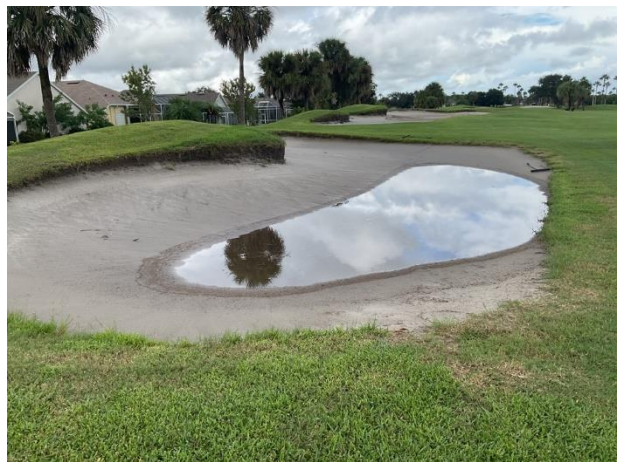
**Condition:** Reported in satisfactory condition. We note standing water after heavy rainfall throughout the course.

**Bunker with standing water after rain at Hole 1**

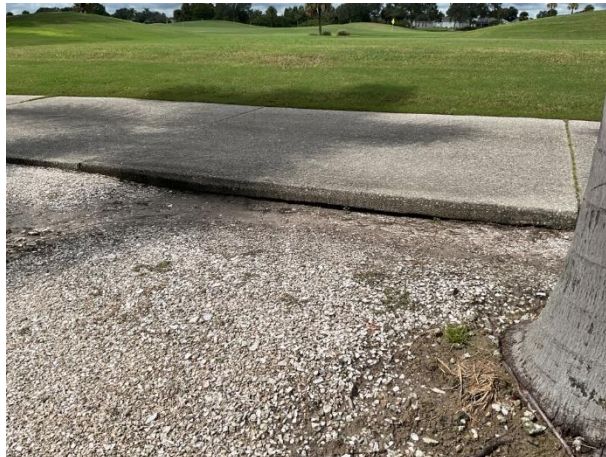
**Condition:** Good to fair overall with cracks and previous partial replacement evident. We note tree root intrusion near the Hole 11 tee and undermining of soil at the Hole 18 tee.

**Soil undermining cart path at graveled area**

**Expenditure Detail Notes:** Expenditure timing and costs are depicted in the **Reserve Expenditures** table in Section 3. We estimate that up to 34,200 square feet of concrete sidewalks, or thirty percent (30%) of the total, will require replacement during the next 30 years.

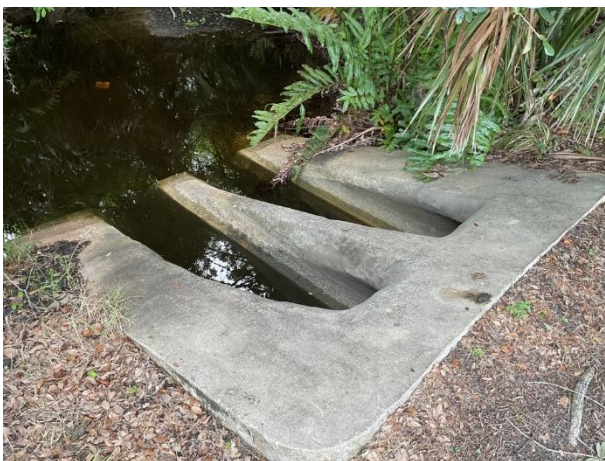
**Condition:** Good to fair overall with cracks evident

Overflow outlet structure

***Expenditure Detail Notes:*** Expenditure timing and costs are depicted in the ***Reserve Expenditures*** table in Section 3. Our estimate of cost for capital repairs includes an allowance for inspection of the concrete structures and replacement or repair of up to five displaced or failed mitered end sections.

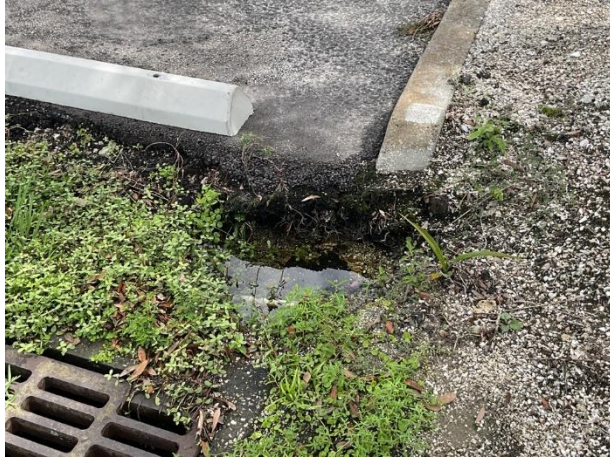
**Condition:** The Clubhouse parking area is in good overall condition with no significant deterioration evident. We note minor raveling, and soil undermining and vehicle fluid stains. The Woodside Park parking area is in fair overall condition with frequent cracks, settlement, tree root intrusion and previous repairs evident.

**Soil undermining pavement at drainage area**

**Component Detail Notes:** Proposals for seal coat applications should include crack repairs and patching. The contractor should only apply seal coat applications after repairs are completed. A seal coat does not bridge or close cracks, therefore, unrepaired cracks render the seal coat applications useless.

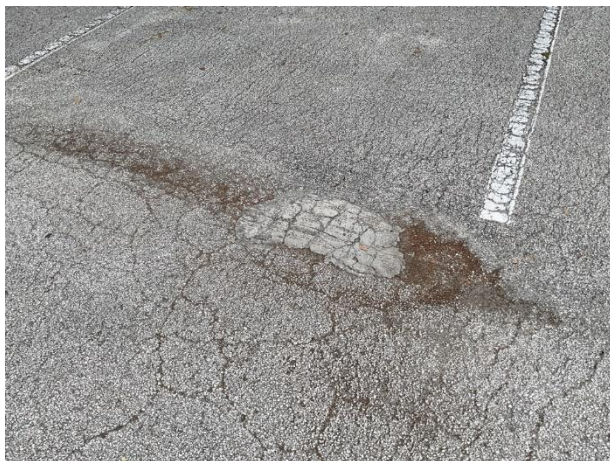
**Evidence of previous attempted repair**

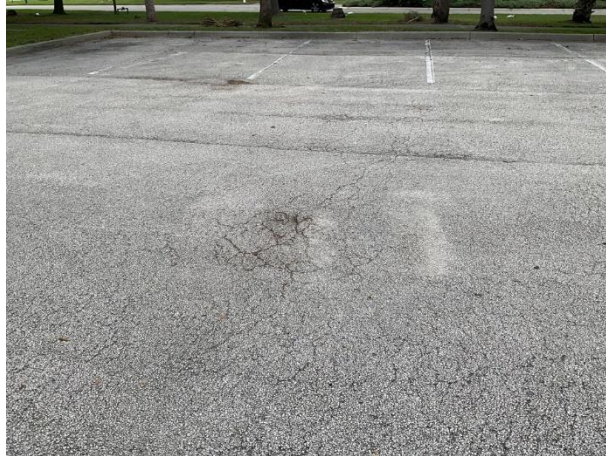
**Pavement cracks and settlement**

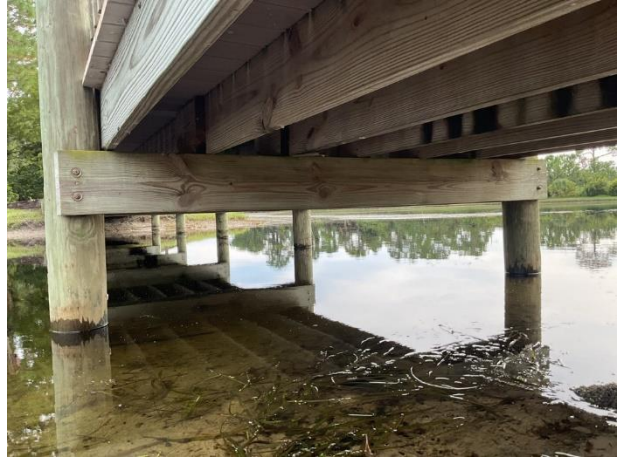
**Bridge structure overview**

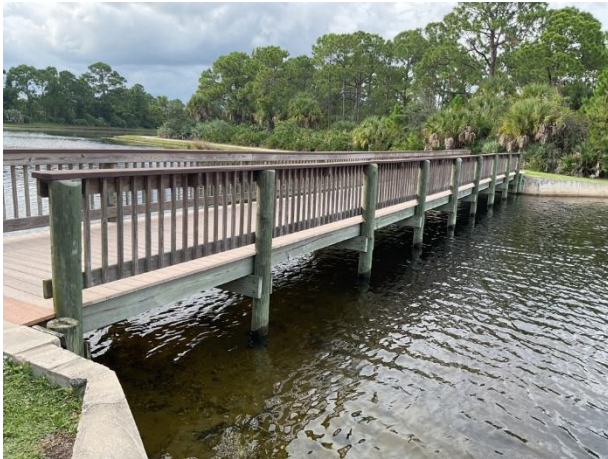
**Bridge with wood structure and railings and composite deck boards**

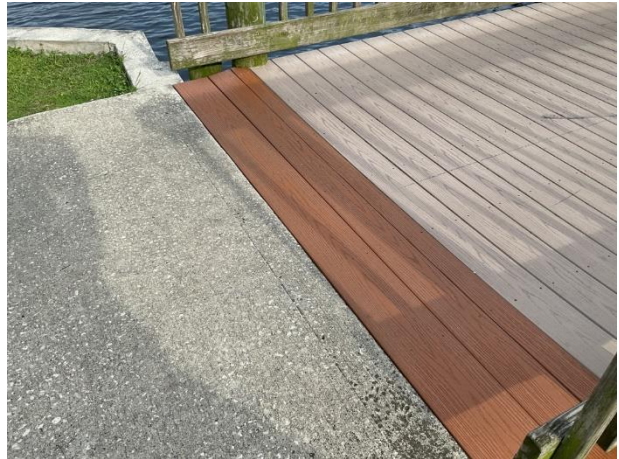
**Evidence of previous partial replacement**

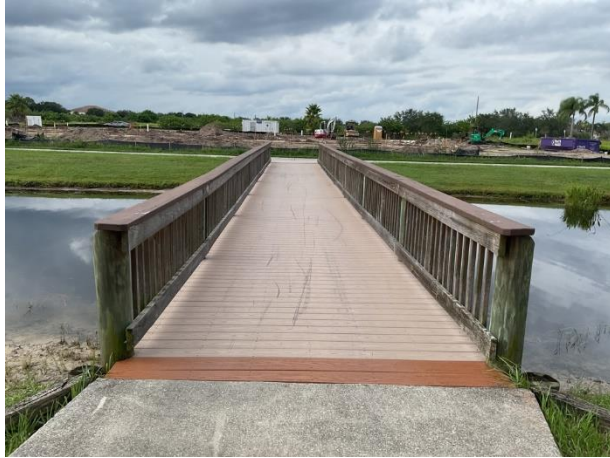
**North bridge overview**

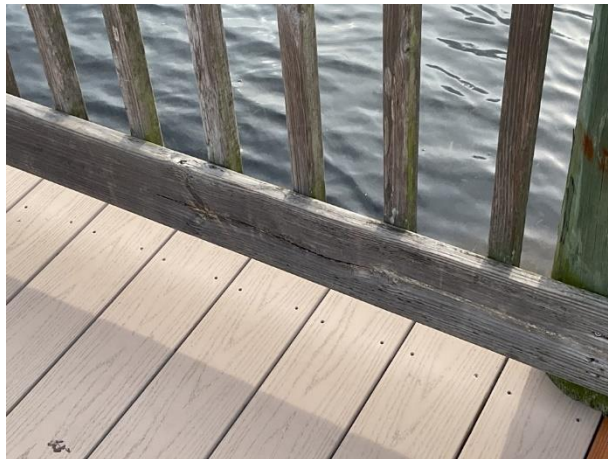
**Wood deterioration at stringer**

- Paint or sealer applications to wood components
- Replacement of a limited quantity of decking
- Replacement of a limited quantity of the wood structure and railings
- Replacement of up to two pilings

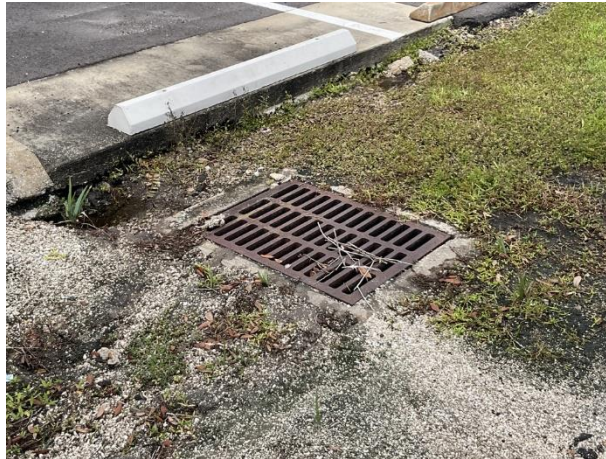
**Condition:** Fair overall with settlement evident

Landscape catch basin at clubhouse parking area

- Annually:
  - Inspect and repair any settlement and collar cracks
  - Ensure proper drainage and inlets are free of debris
  - If property drainage is not adequate in heavy rainfall events, typically bi-annual cleaning of the catch basins is recommended

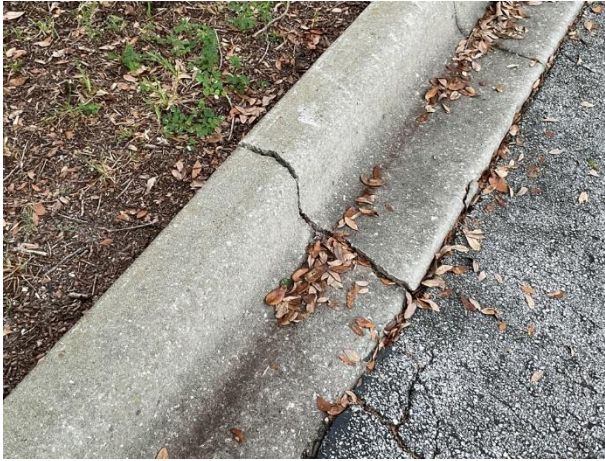
**Concrete crack with tree root upheaval at Woodside Park**

- Annually:
  - Inspect and repair major cracks, spalls and trip hazards
  - Mark with orange safety paint prior to replacement or repair
  - Repair or perform concrete leveling in areas in immediate need of repair or possible safety hazard

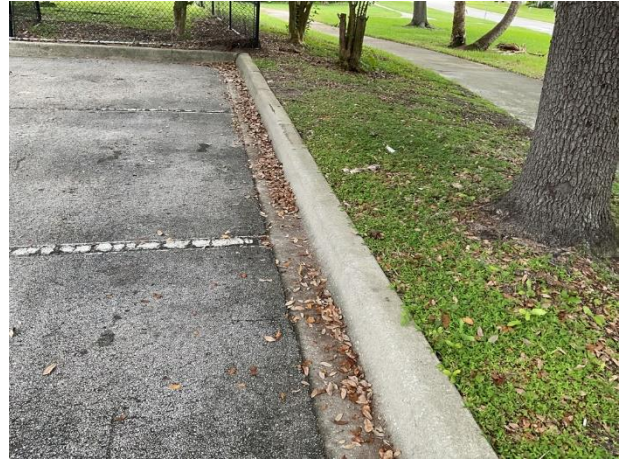
**Concrete curb and gutter at Woodside Park**

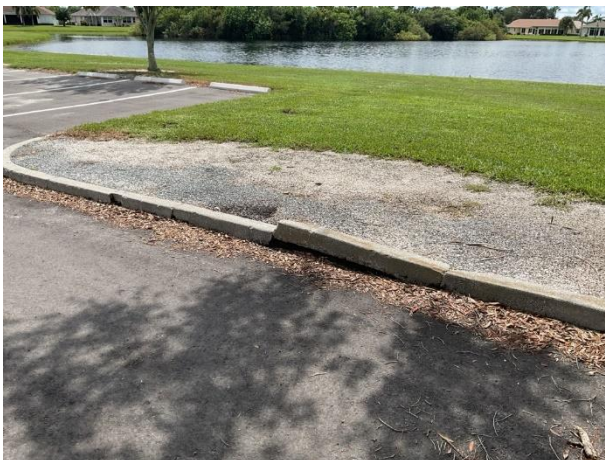
**Concrete curb upheaval at the Clubhouse parking area**

**Expenditure Detail Notes:** Expenditure timing and costs are depicted in the **Reserve Expenditures** table in Section 3. We estimate that up to 1,340 linear feet of curbs and gutters at the Clubhouse parking area and access drive, or twenty percent (20%) of the total, will require replacement during the next 30 years. Due to the small quantity, we estimate that up to 600 linear feet of curbs and gutters at Woodside Park, or eighty percent (80%) of the total, will require replacement during the next 30 years.

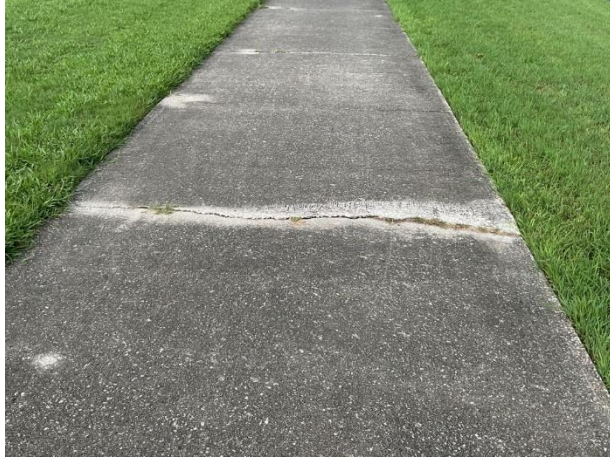
**Evidence of previous repair at Woodside Park**

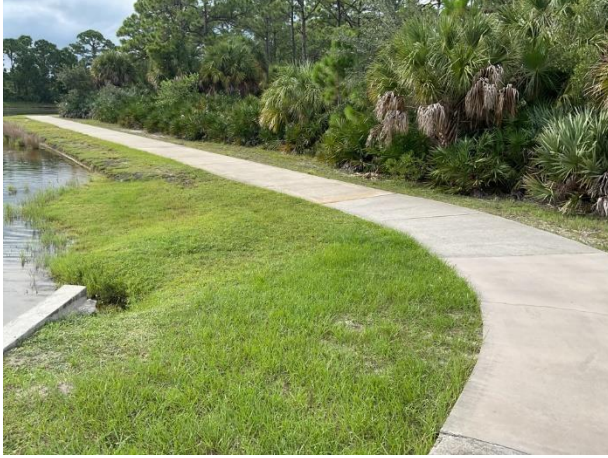
**Concrete sidewalk overview on island**

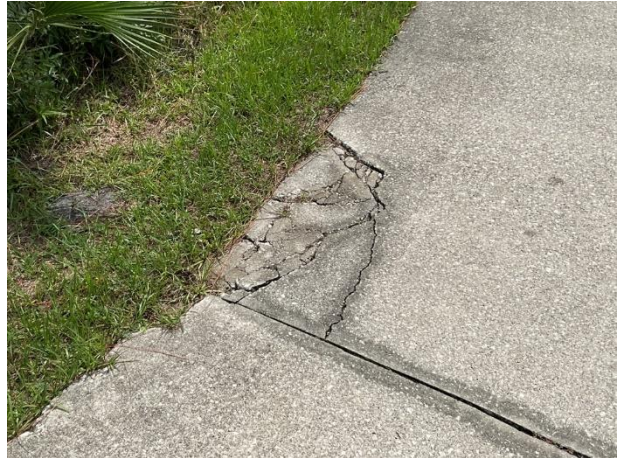
**Concrete walking trail settlement**

- Annually:
  - Inspect and repair major cracks, spalls and trip hazards
  - Mark with orange safety paint prior to replacement or repair
  - Repair or perform concrete leveling in areas in immediate need of repair or possible safety hazard

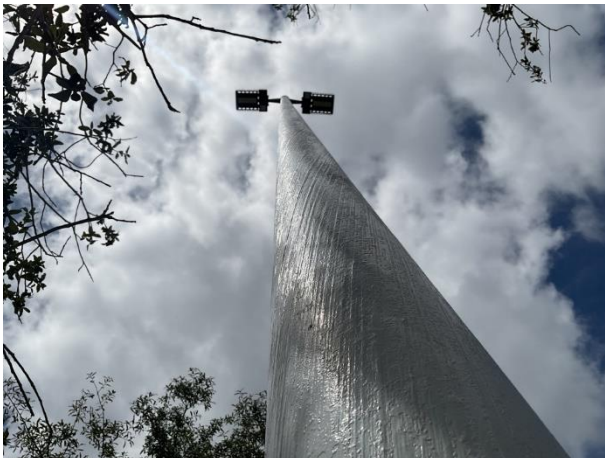
Fiberglass light pole with paint finishes

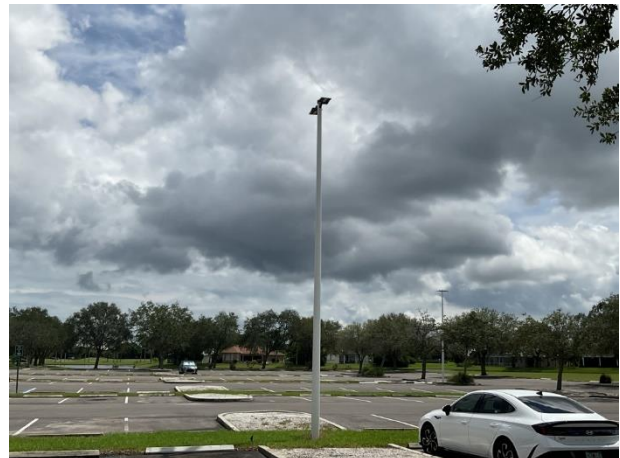
Light pole with LED fixtures at the clubhouse parking area

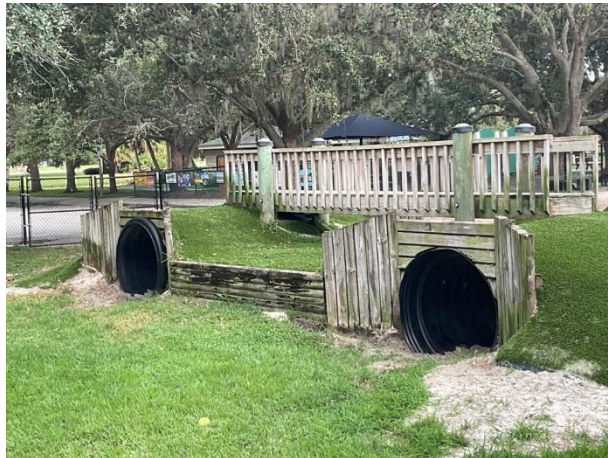
**Tunnels underneath bridge**

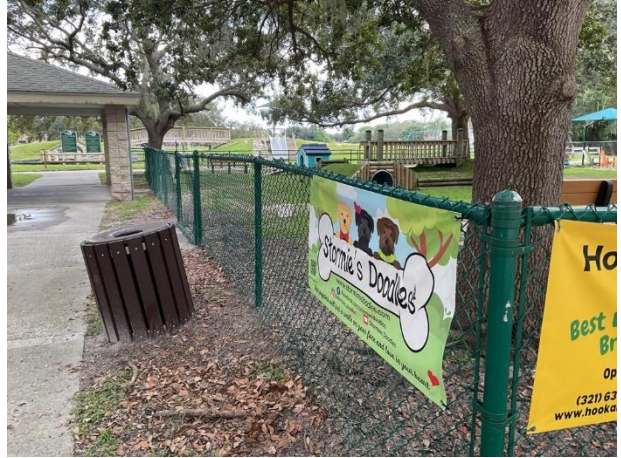
**Chain link fence**

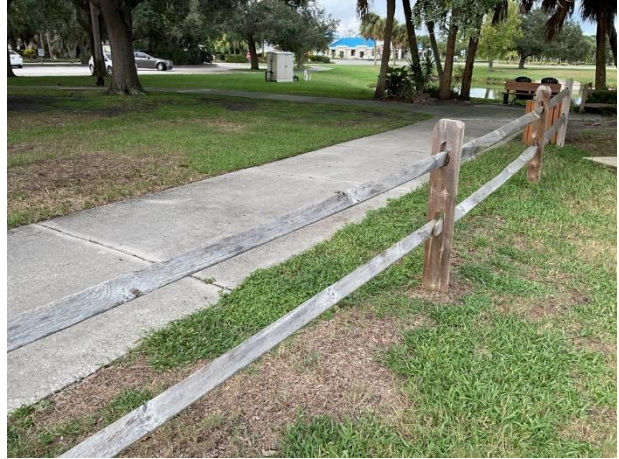
**Wood split rail fence at playground area**

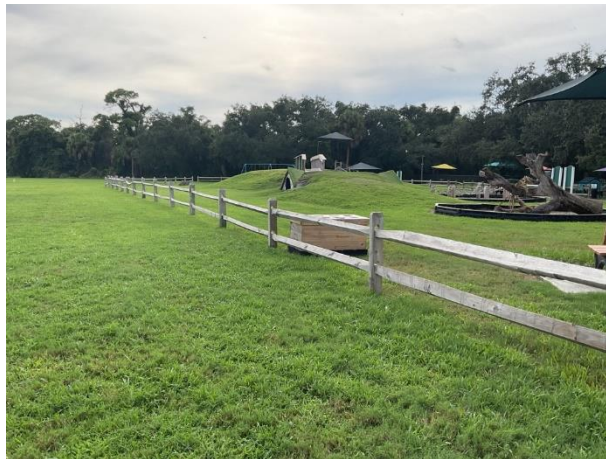
**Wood split rail fence at playground**

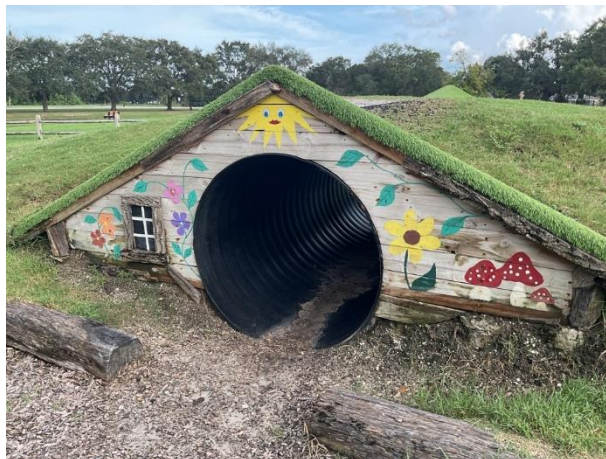
**Tunnel with decorative façade**

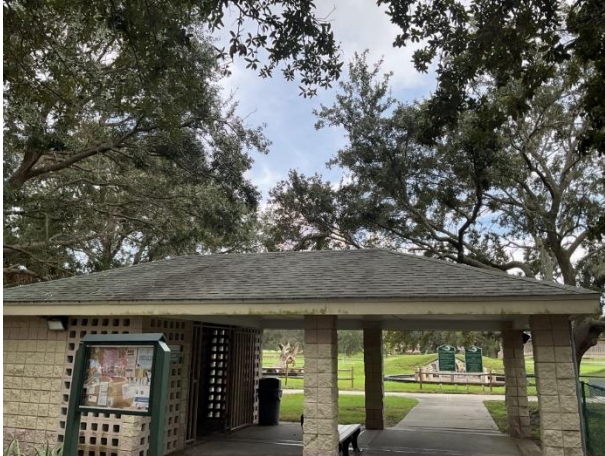
**Condition:** The rest rooms are in good to fair overall condition. The exterior paint finishes are in fair overall condition with stains evident. The roof assembly is in fair to poor overall condition with discoloration evident.

**Asphalt shingle overview with discoloration at shingles and fascia board**

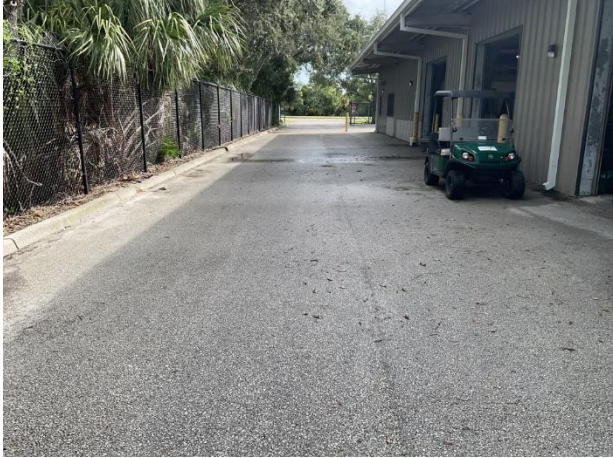
**Condition:** Fair overall with cracks and settlement evident

**Asphalt pavement at maintenance facility**

**Component Detail Notes:** Proposals for seal coat applications should include crack repairs and patching. The contractor should only apply seal coat applications after repairs are completed. A seal coat does not bridge or close cracks, therefore, unrepaired cracks render the seal coat applications useless.

**Expenditure Detail Notes:** Expenditure timing and costs are depicted in the **Reserve Expenditures** table in Section 3. Our cost for repair includes an allowance for patching of up to two percent (2%) of the pavement. Our cost for milling and overlayment includes area patching of up to ten percent (10%).

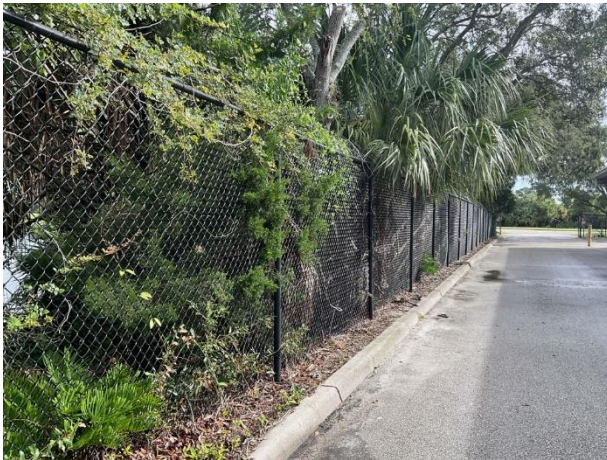
**Condition:** Good to fair overall with finish deterioration and disconnected components evident.

**Chain link perimeter fence at maintenance facility**

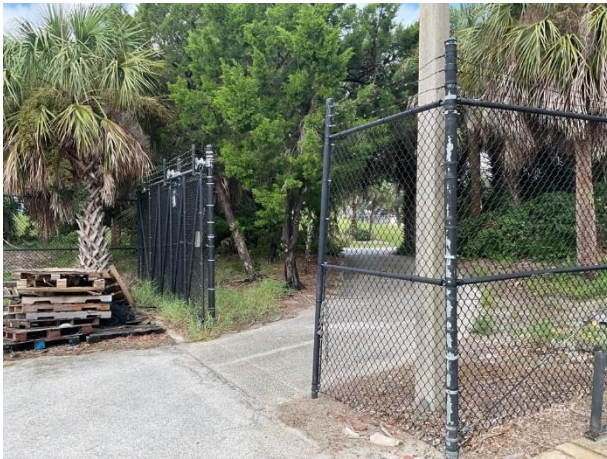
**Rear gate at maintenance facility with finish deterioration**

**Expenditure Detail Notes:** Expenditure timing and costs are depicted in the **Reserve Expenditures** table in Section 3. Our estimate of cost includes an allowance for replacement of the rolling gate at the main entrance and the swinging gate at the rear entrance.

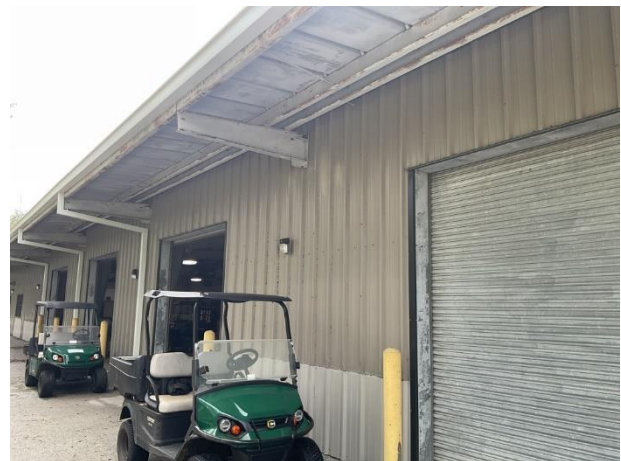
**Condition:** Fair overall with rust and partial siding replacements evident. Management does not report significant roof leaks

**Metal siding at maintenance building**

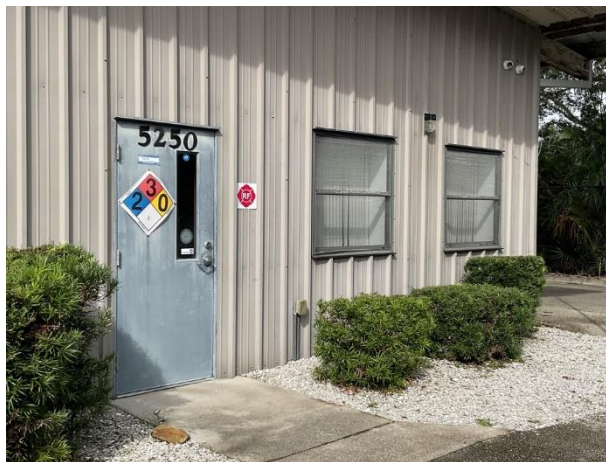
**Condition:** Good overall with no visible deterioration. We note minor finish deterioration at the entrance door.

Windows and doors at maintenance office
