# Viera East Community Development District

Inspected: September 12, 2024 • Revised on: June 06, 2025  
Rockledge, FL

RESERVE STUDY

Viera East Community Development District  
Rockledge, Florida

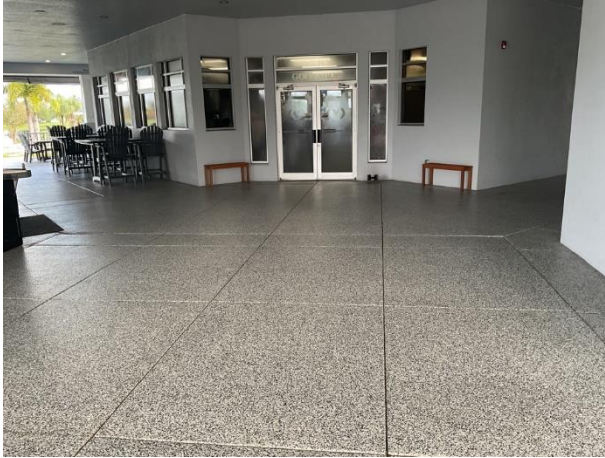
**Condition:** Good overall with no visible deterioration

**Gemstone coating at Clubhouse**

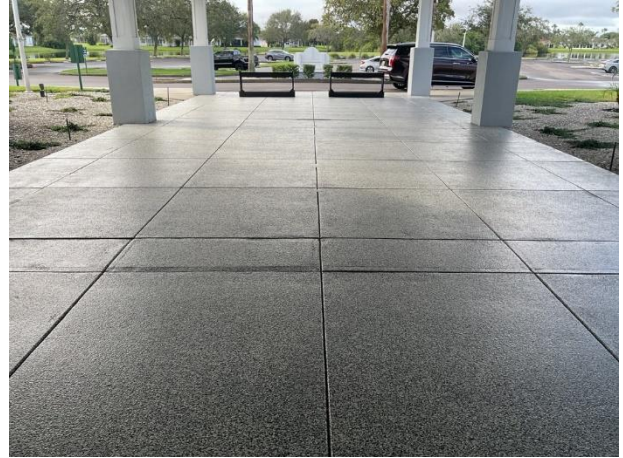
**Gemstone coating at portico**

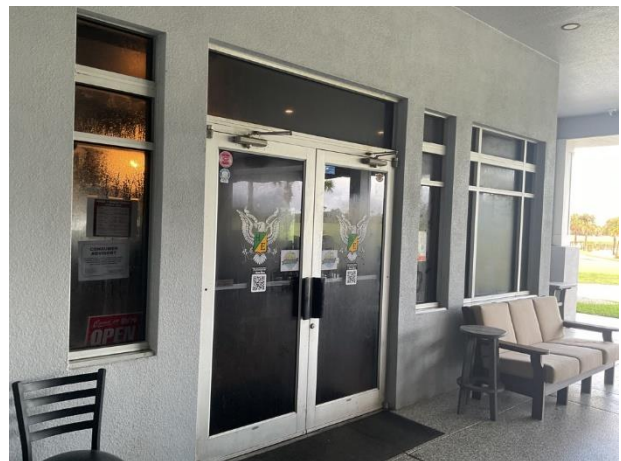
**Condition:** Good to fair overall with no significant visible deterioration

Windows and doors at restaurant

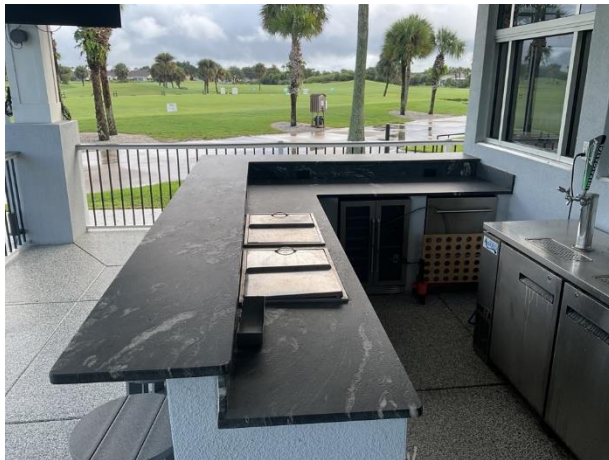
**Condition:** Good overall

Bar and countertop at outdoor seating area

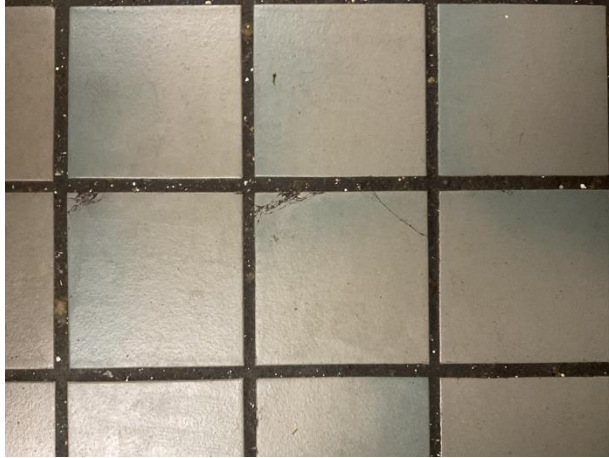
**Condition:** Fair overall with cracks and damaged tiles evident

**Tile cracks**

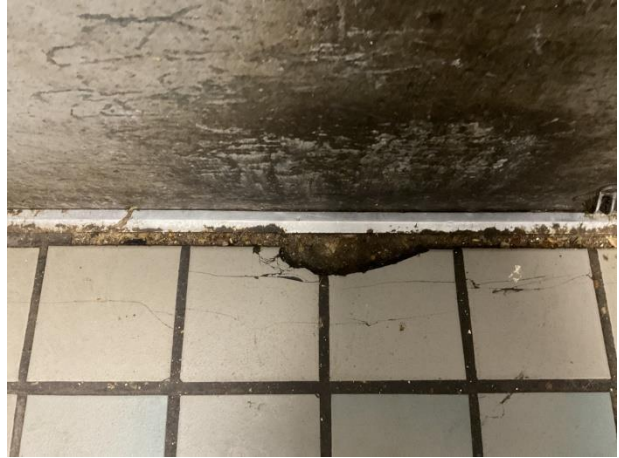
**Tile damage**

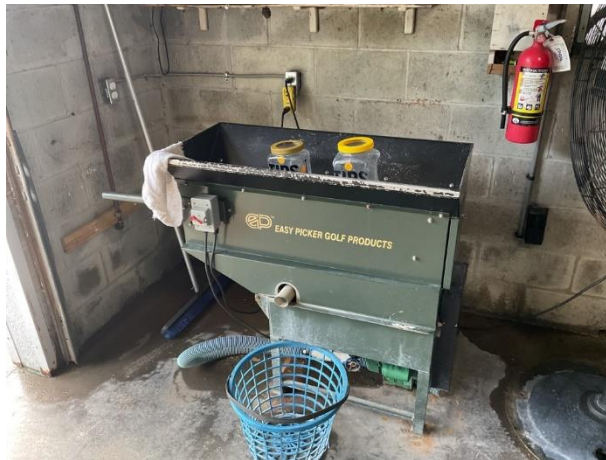
**Condition:** Reported in satisfactory condition. We note finish deterioration

Ball washing station

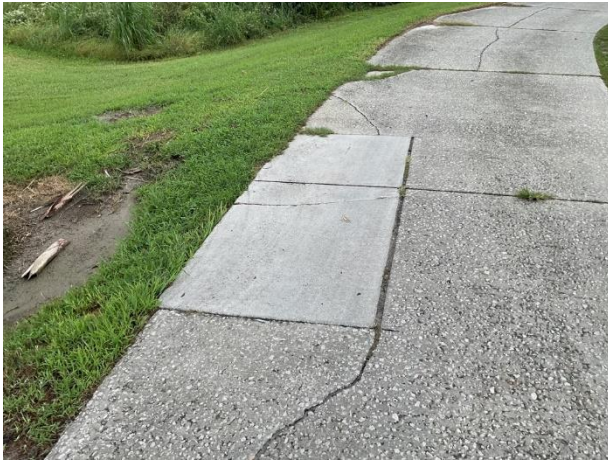
**Condition:** Good to fair overall with cracks and previous partial replacement evident. We note tree root intrusion near the Hole 11 tee and undermining of soil at the Hole 18 tee.

**Previous partial replacement**

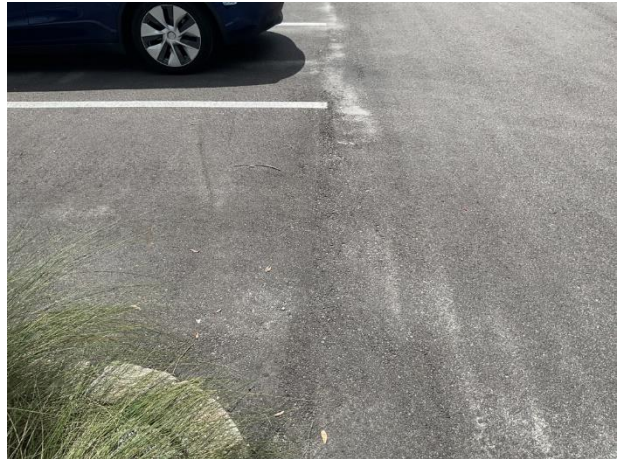
**Condition:** The Clubhouse parking area is in good overall condition with no significant deterioration evident. We note minor raveling, and soil undermining and vehicle fluid stains. The Woodside Park parking area is in fair overall condition with frequent cracks, settlement, tree root intrusion and previous repairs evident.

Pavement raveling

**Component Detail Notes:** Proposals for seal coat applications should include crack repairs and patching. The contractor should only apply seal coat applications after repairs are completed. A seal coat does not bridge or close cracks, therefore, unrepaired cracks render the seal coat applications useless.

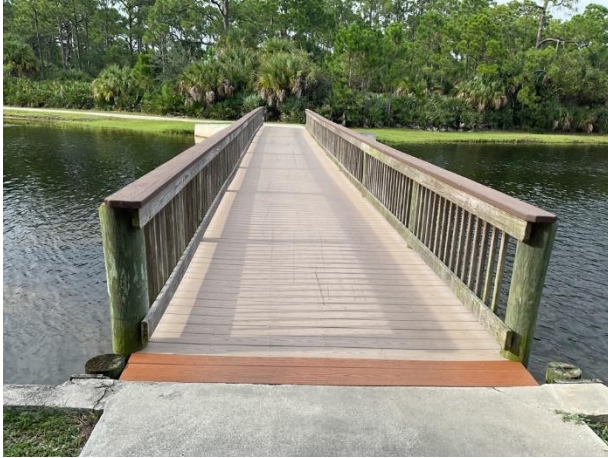
**Condition:** Fair overall with evidence of previous partial decking replacement, thermal damage at decking, coating deterioration and wood rot evident.

**Bridge overview**

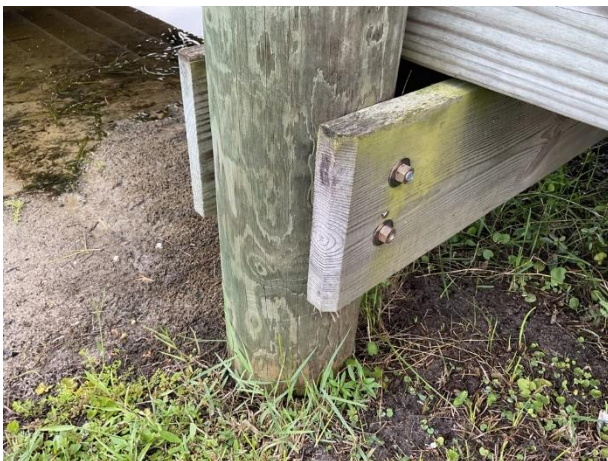
**Fasteners detail**

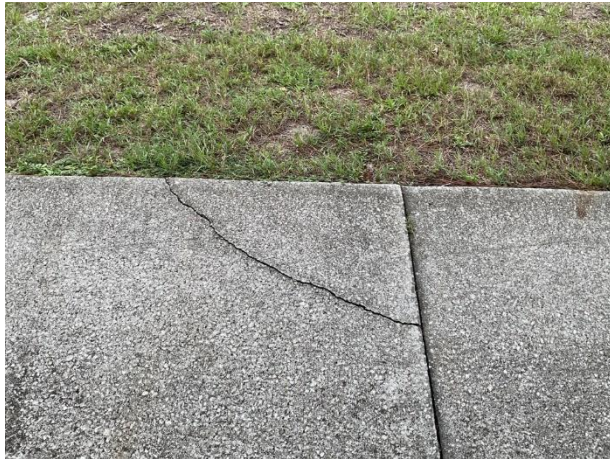
**Concrete crack**

- Annually:
  - Inspect and repair major cracks, spalls and trip hazards
  - Mark with orange safety paint prior to replacement or repair
  - Repair or perform concrete leveling in areas in immediate need of repair or possible safety hazard

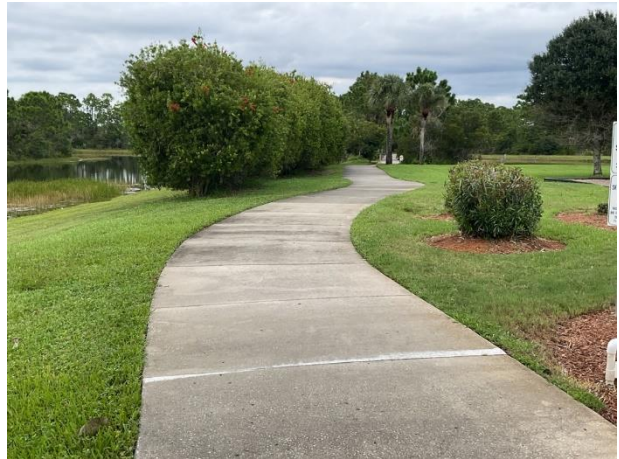
**Concrete overview at Viera nature trail**

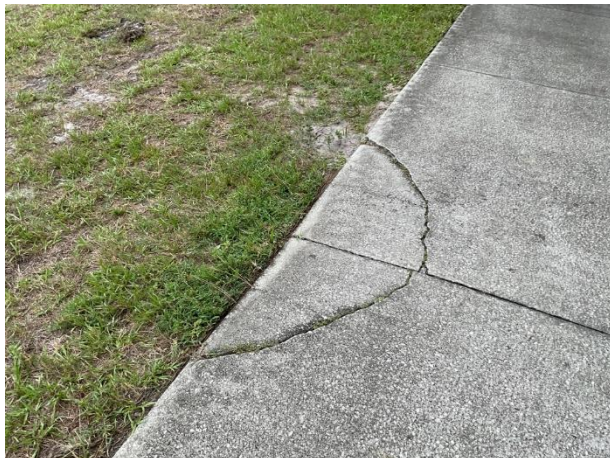
**Concrete settlement**

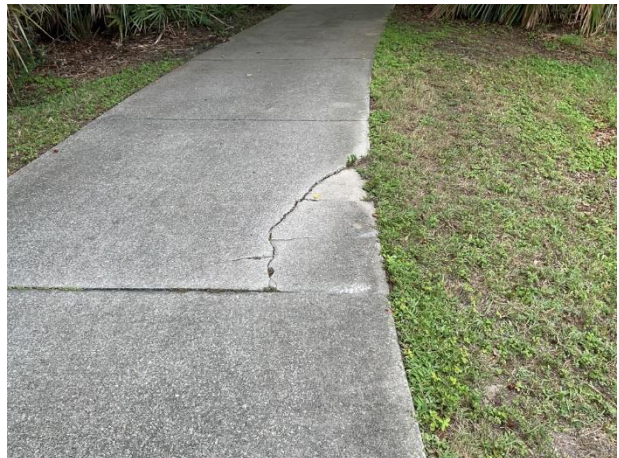
**Concrete settlement**

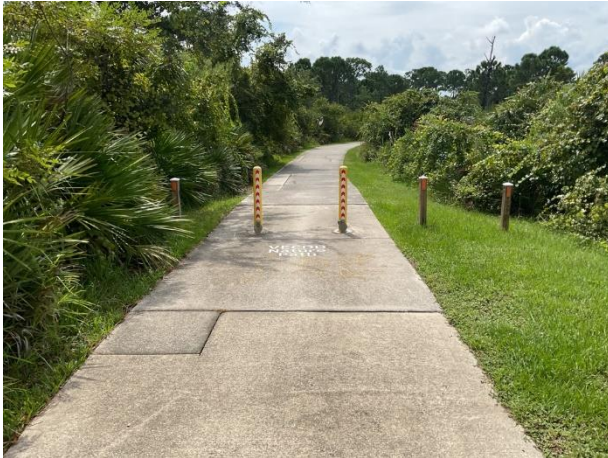
**Concrete walking trail near Manchester Drive**

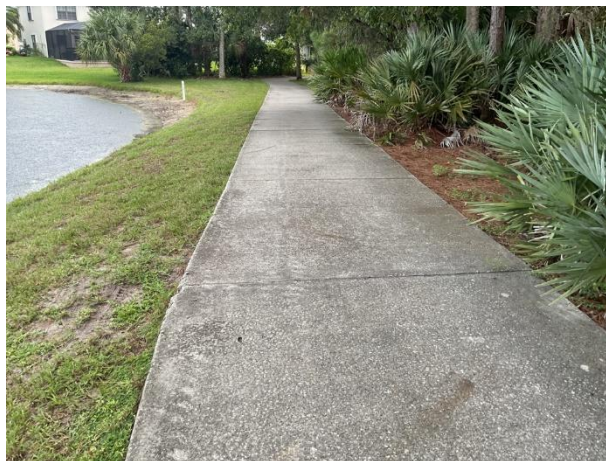
**Walking trail overview**

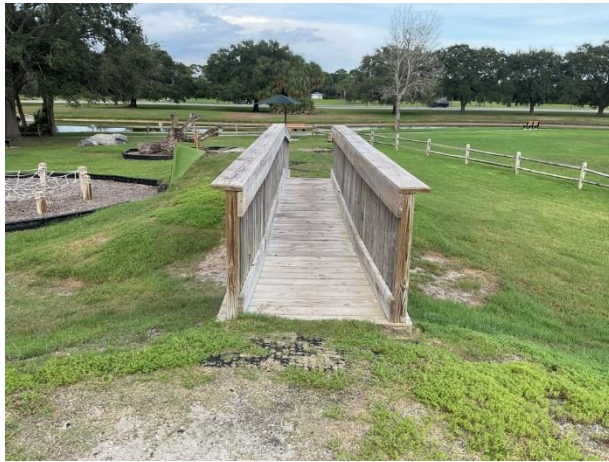
**Condition:** Good to fair overall with rust evident at fasteners

Bridge at playground area

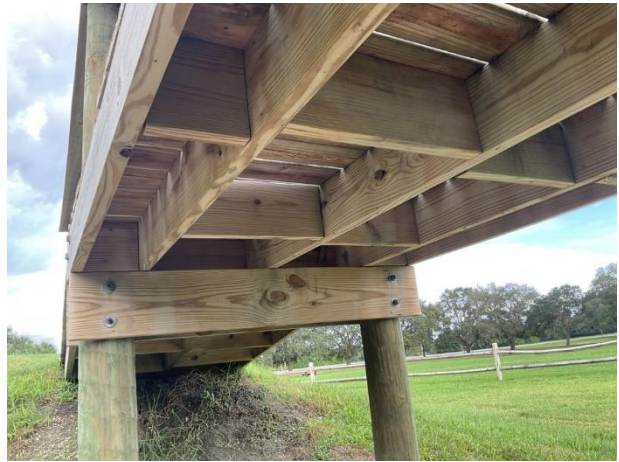
Bridge structure

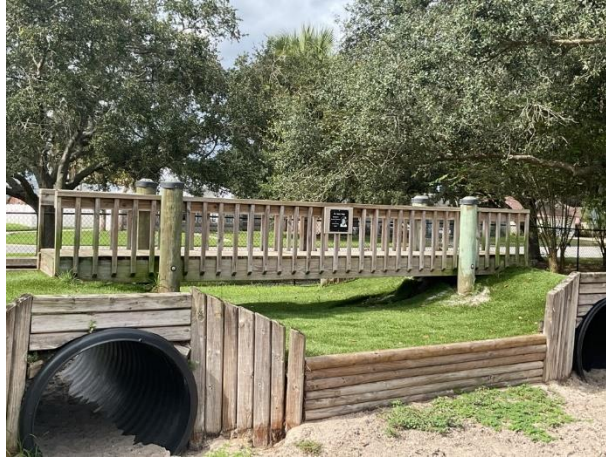
**Wood bridge at dog park**

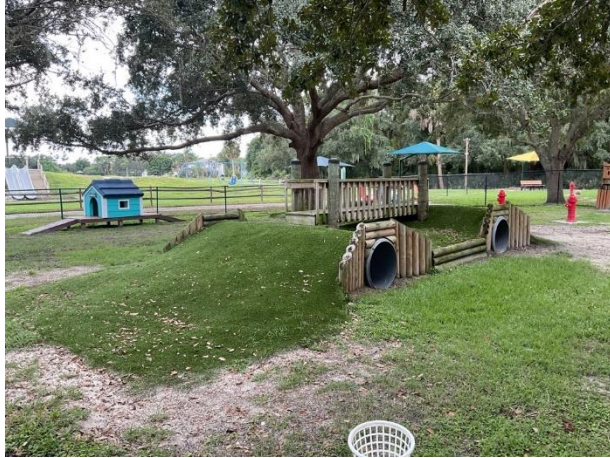
**Dog park features including tunnels, doghouse and fire hydrants**

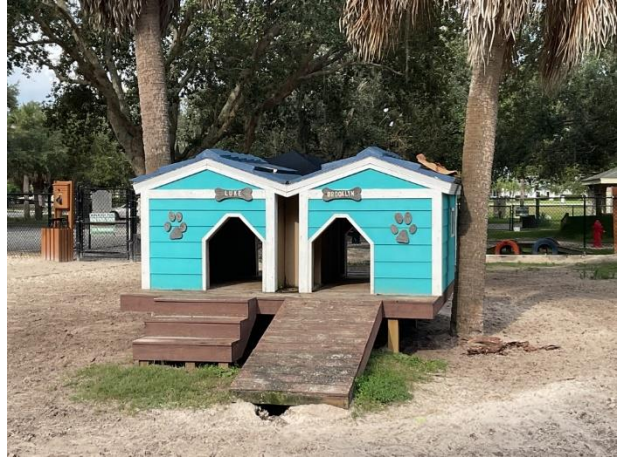
**Dog park features**

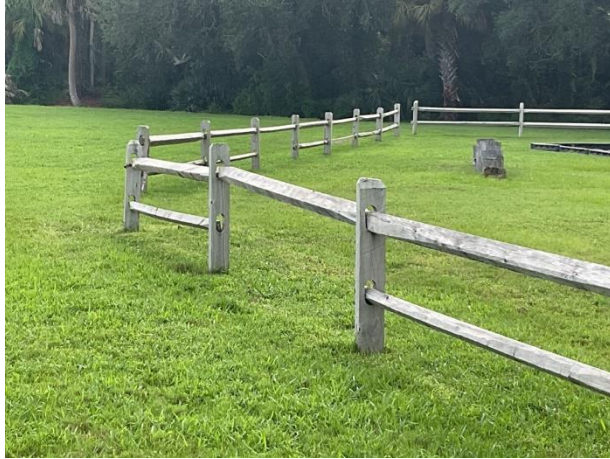
**Condition:** Good to fair overall with isolated missing rails

**Missing rails**

- Annually:
  - Inspect and repair loose sections, and damage
  - Repair leaning sections and clear vegetation from fence areas which could cause damage

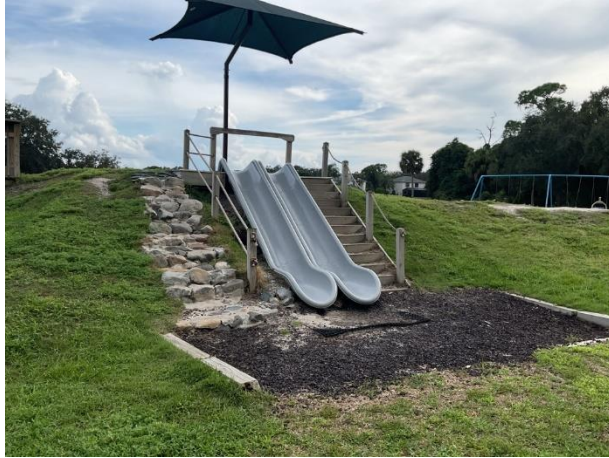
**Slides**

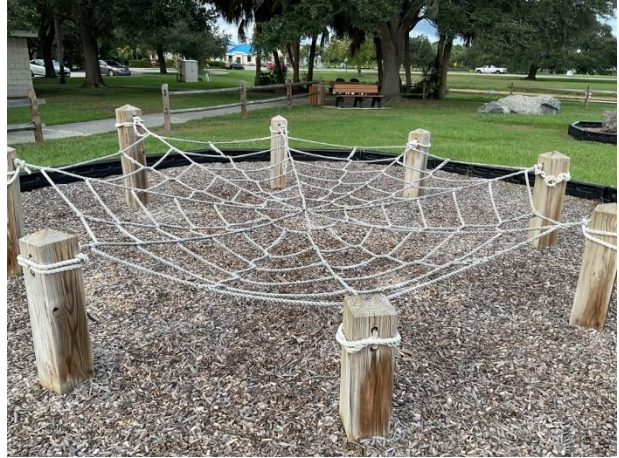
**Ropes climbing area**

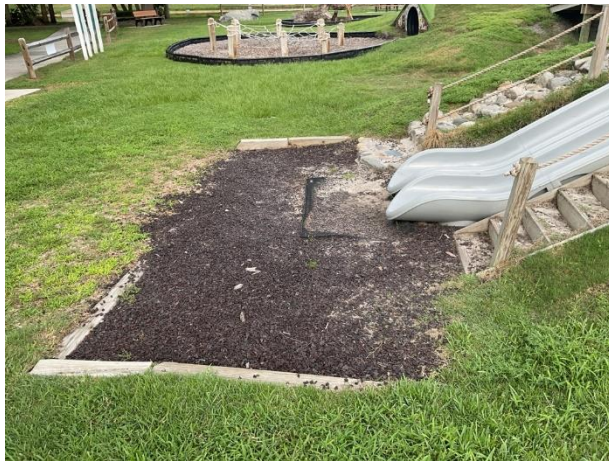
**Rubberized safety surface**

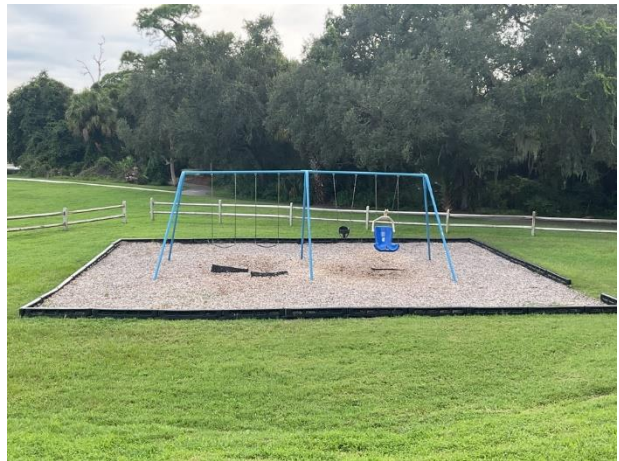
**Swing set with wood safety surface and plastic border**

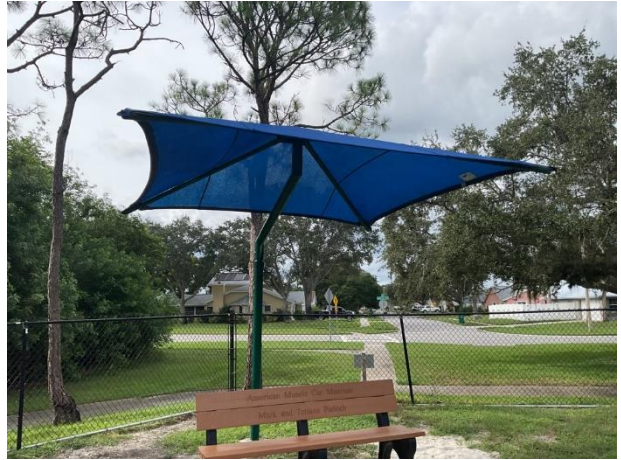
**Condition:** Good to fair overall with rust and stained canvas evident

**Rust at frame**

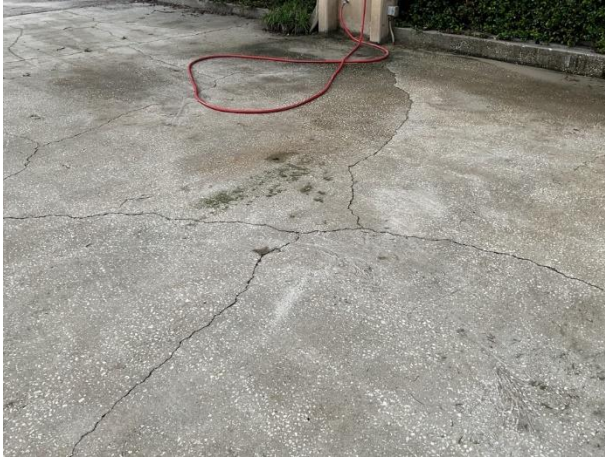
**Condition:** Good to fair overall with cracks evident

**Concrete cracks**

**Expenditure Detail Notes:** Expenditure timing and costs are depicted in the **Reserve Expenditures** table in Section 3. We estimate that up to 2,850 square feet of concrete flatwork, or forty percent (40.1%) of the total, will require replacement during the next 30 years.

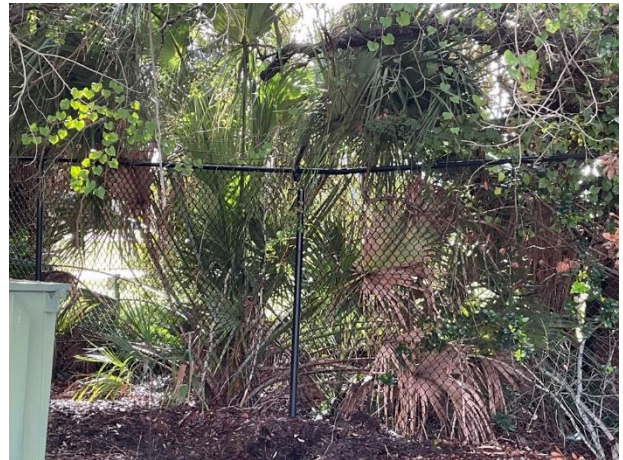
**Condition:** Good to fair overall with finish deterioration and disconnected components evident.

**Disconnected section**

**Expenditure Detail Notes:** Expenditure timing and costs are depicted in the **Reserve Expenditures** table in Section 3. Our estimate of cost includes an allowance for replacement of the rolling gate at the main entrance and the swinging gate at the rear entrance.

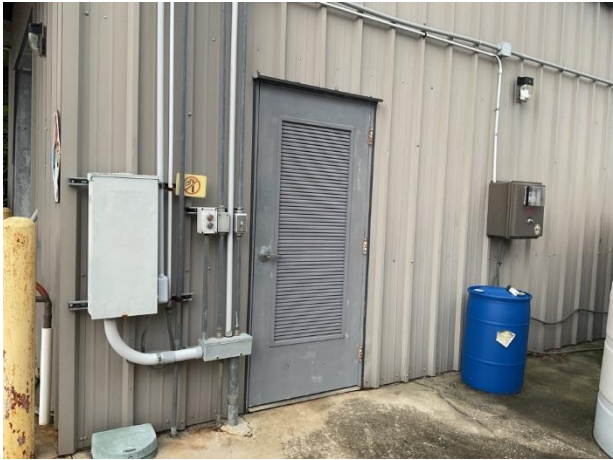
**Conditions:** The utility and overhead doors appear in good to fair overall condition with paint finish deterioration evident. The exhaust fan was in operation at the time of our inspection and Management did not report any deficiencies. The metal framing, siding and roofing is in fair overall condition with rust evident.

**Utility door**

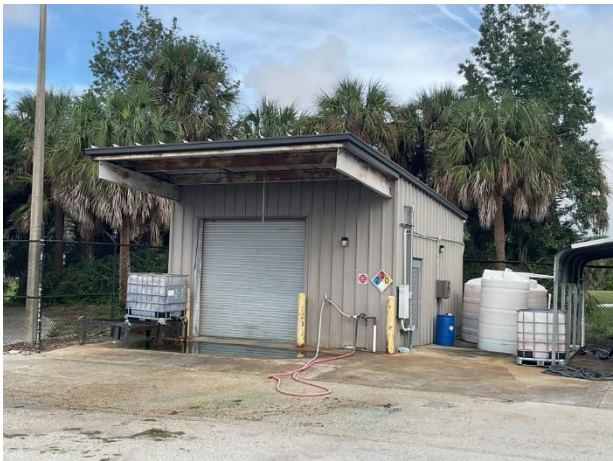
**Fertilizer building**

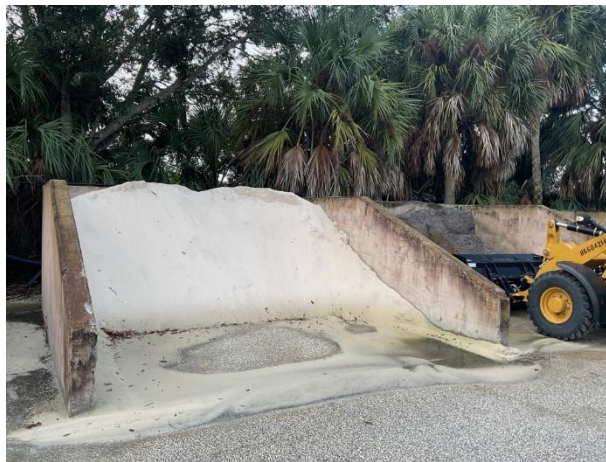
**Condition:** Fair overall with concrete cracks and spalled concrete

**Material storage bins**

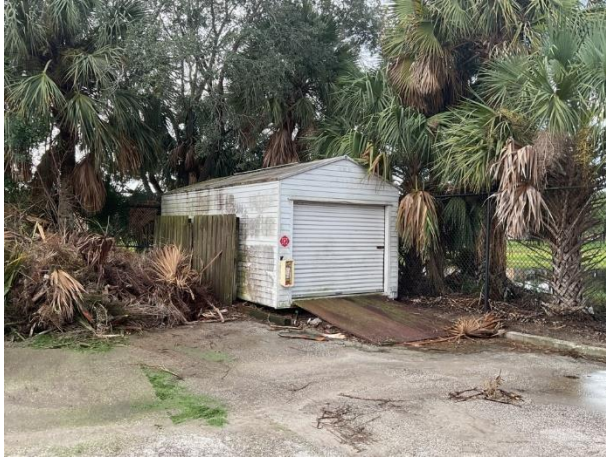
**Condition:** Good to fair overall. We note organic growth at the metal siding

**Storage shed**

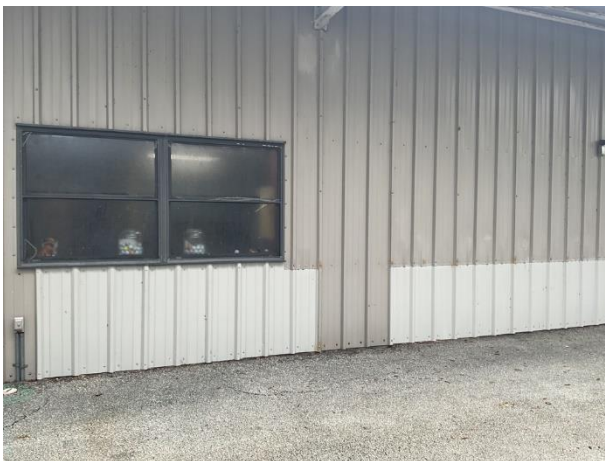
**Condition:** Fair overall with rust and partial siding replacements evident. Management does not report significant roof leaks

**Evidence of partial replacement**
